Just a Few Recent Trenchless Natural Gas Incidents

Recent HDD Incidents

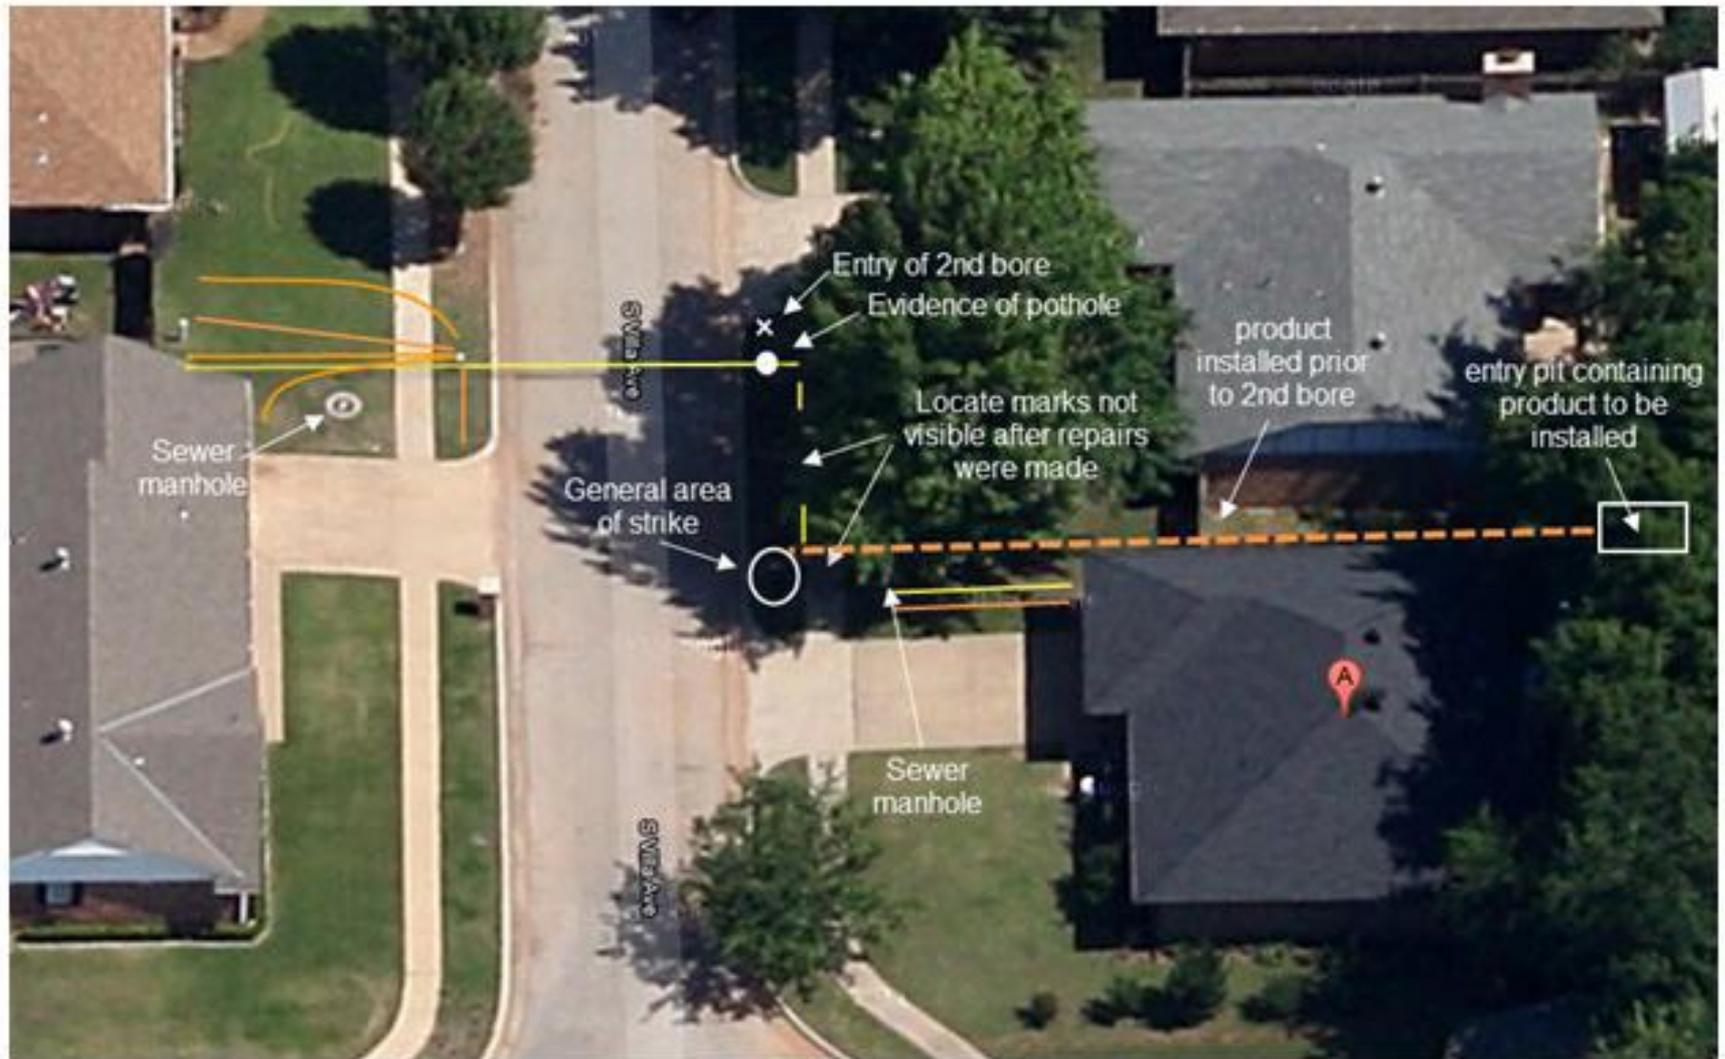
Oklahoma City – January 2013

Sub-contractor installing telecom lines parallel to gas line

Aerial view of area prior to explosion obtained from Google Earth and revised with site information.

- marked phone/cable line
- marked natural gas line
- - - phone line installed by contractor prior to 2nd bore

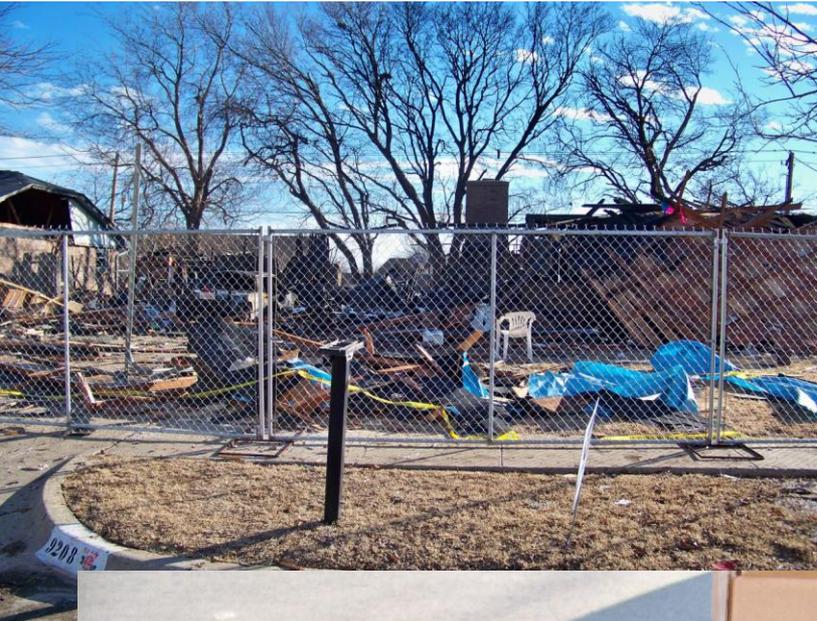
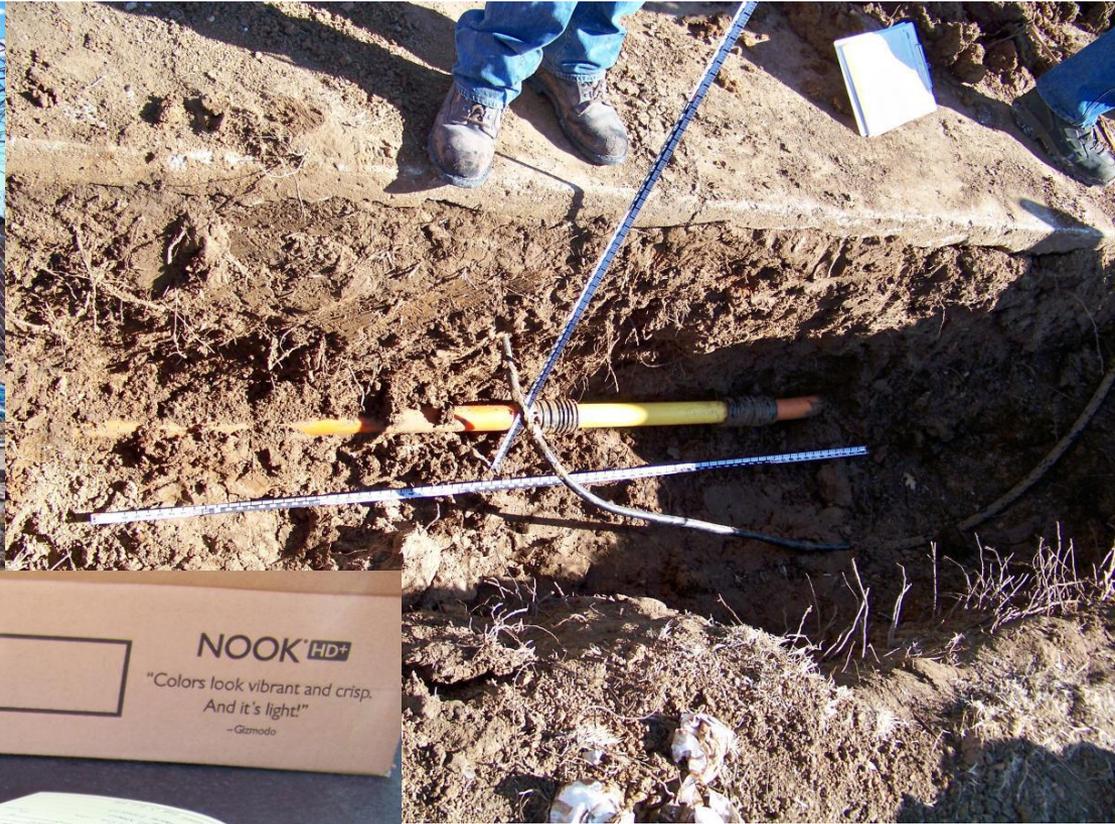
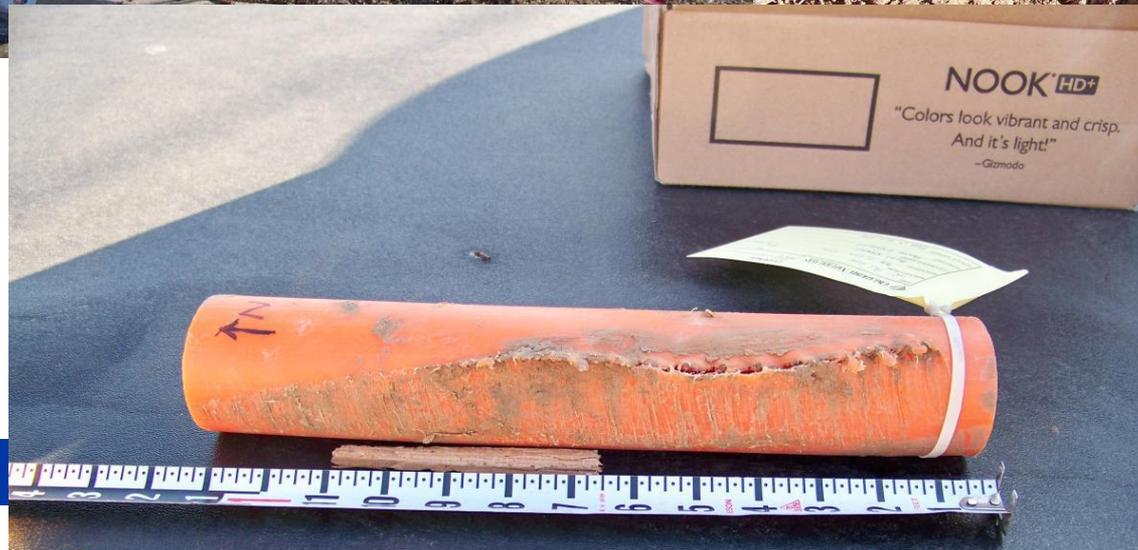
Oklahoma City – January 2013

Sub-contractor installing telecom lines parallel to gas line

Injuries and house destroyed

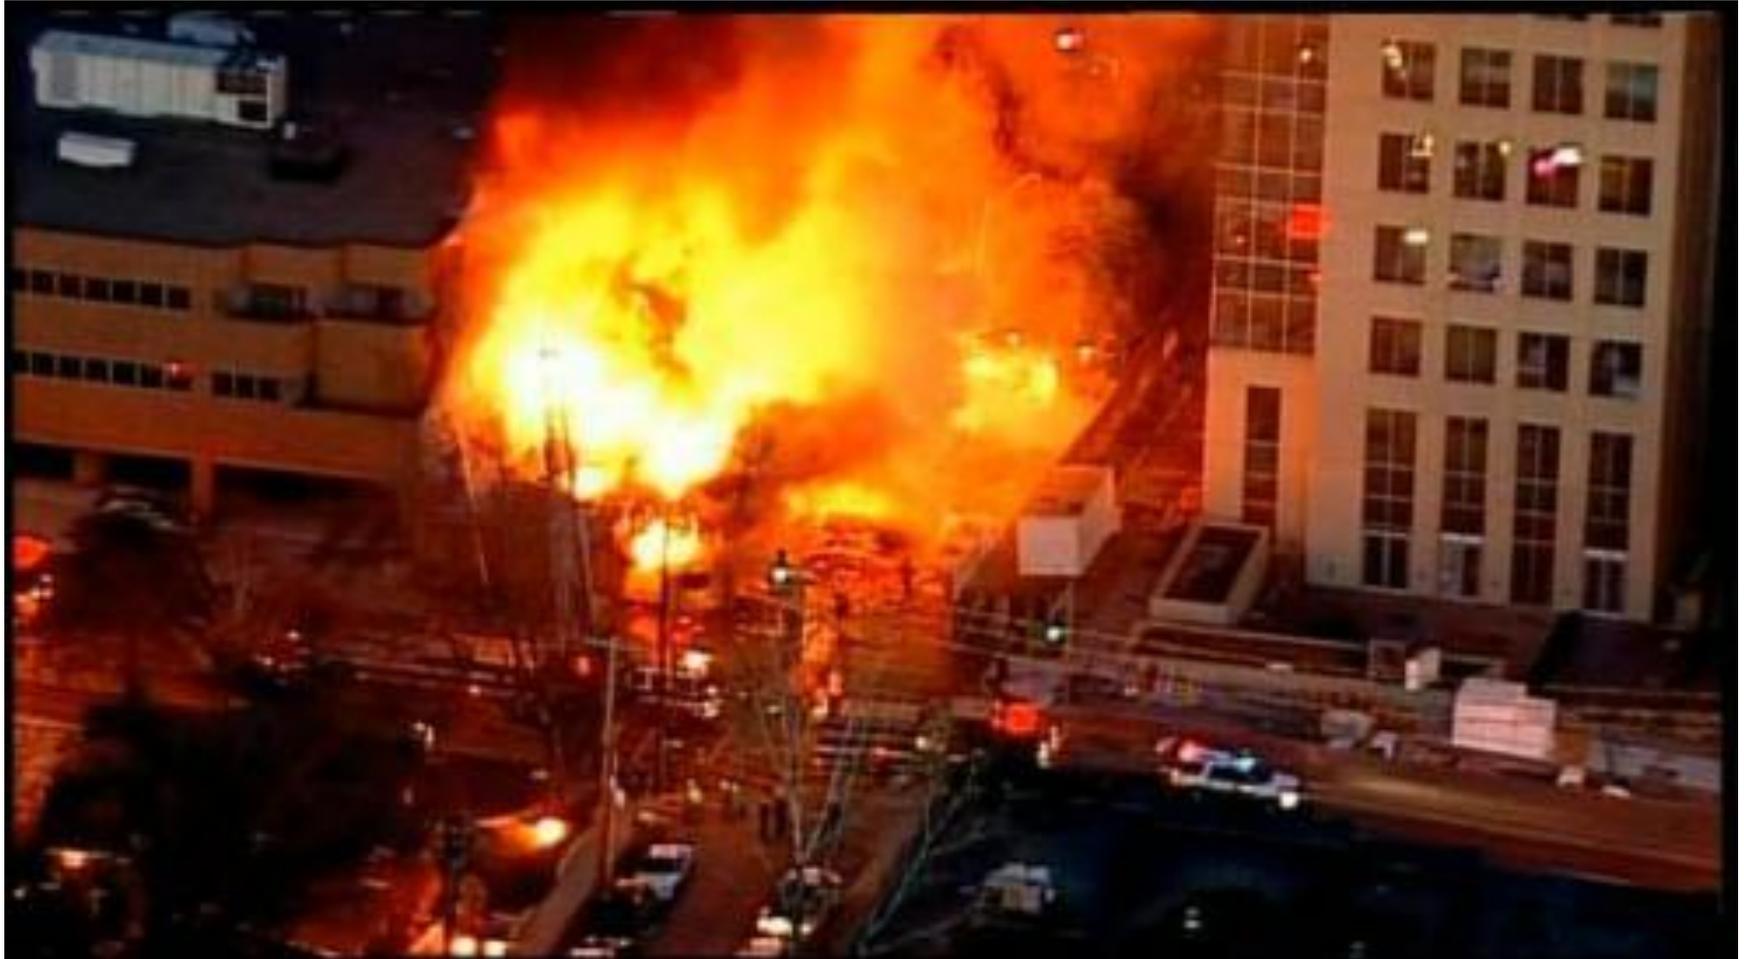
JJ's Restaurant in Kansas City, MO – Feb 19, 2013

One death, multiple serious injuries -- Business destroyed, many bldgs damaged
Contractor installing telecom line across gas line

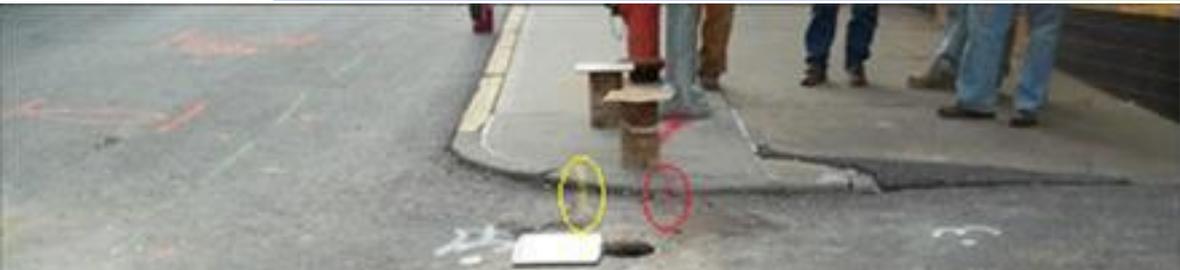
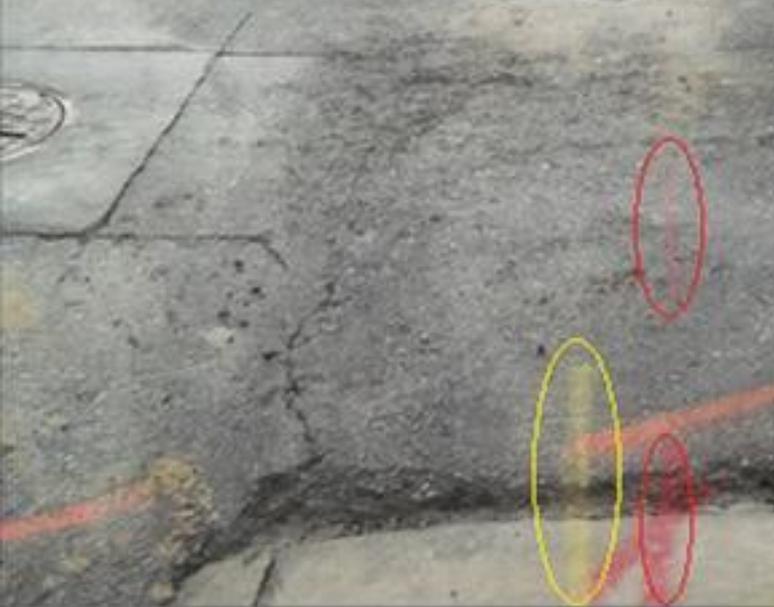
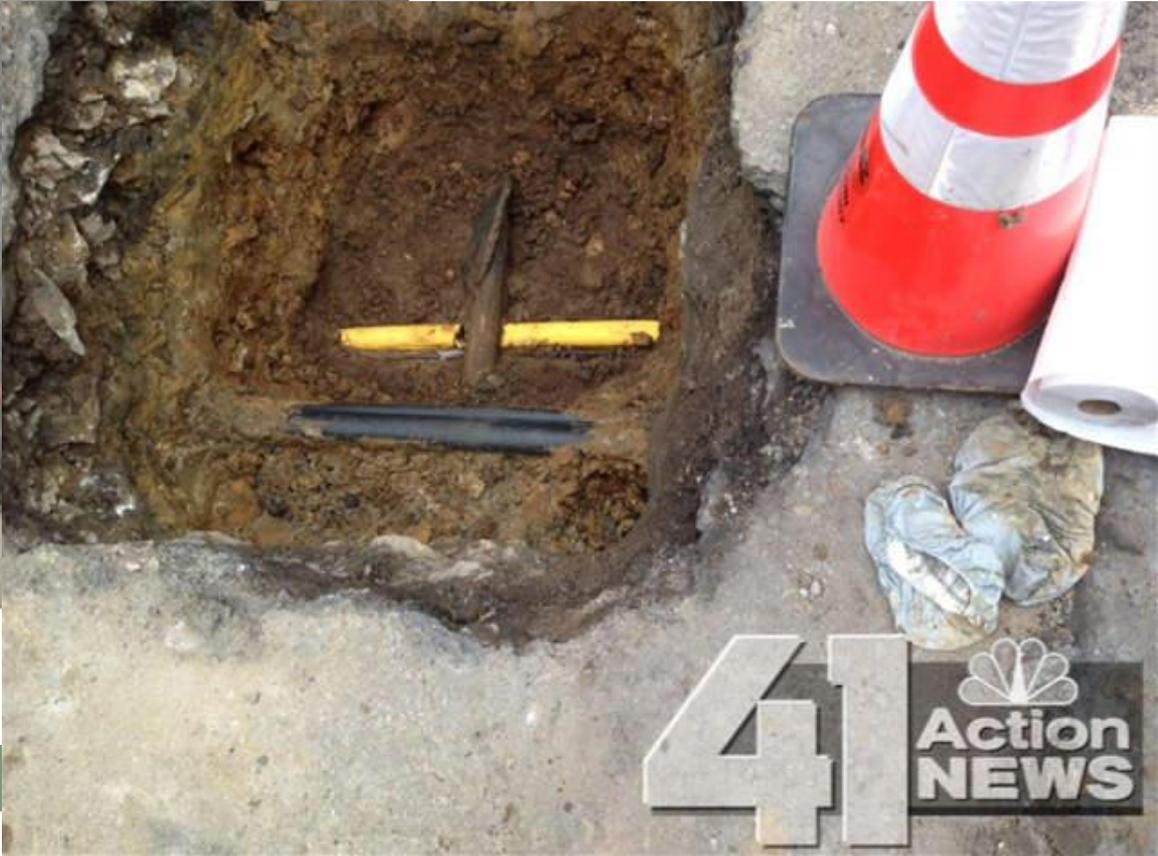
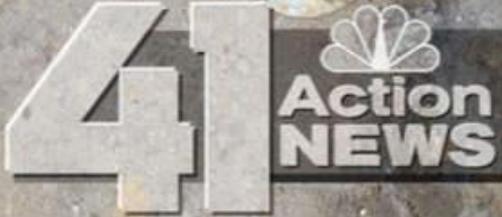
JJ's Restaurant in Kansas City, MO – Feb 19, 2013

One death, multiple serious injuries -- Business destroyed, many bldgs damaged

Contractor installing telecom line across gas line

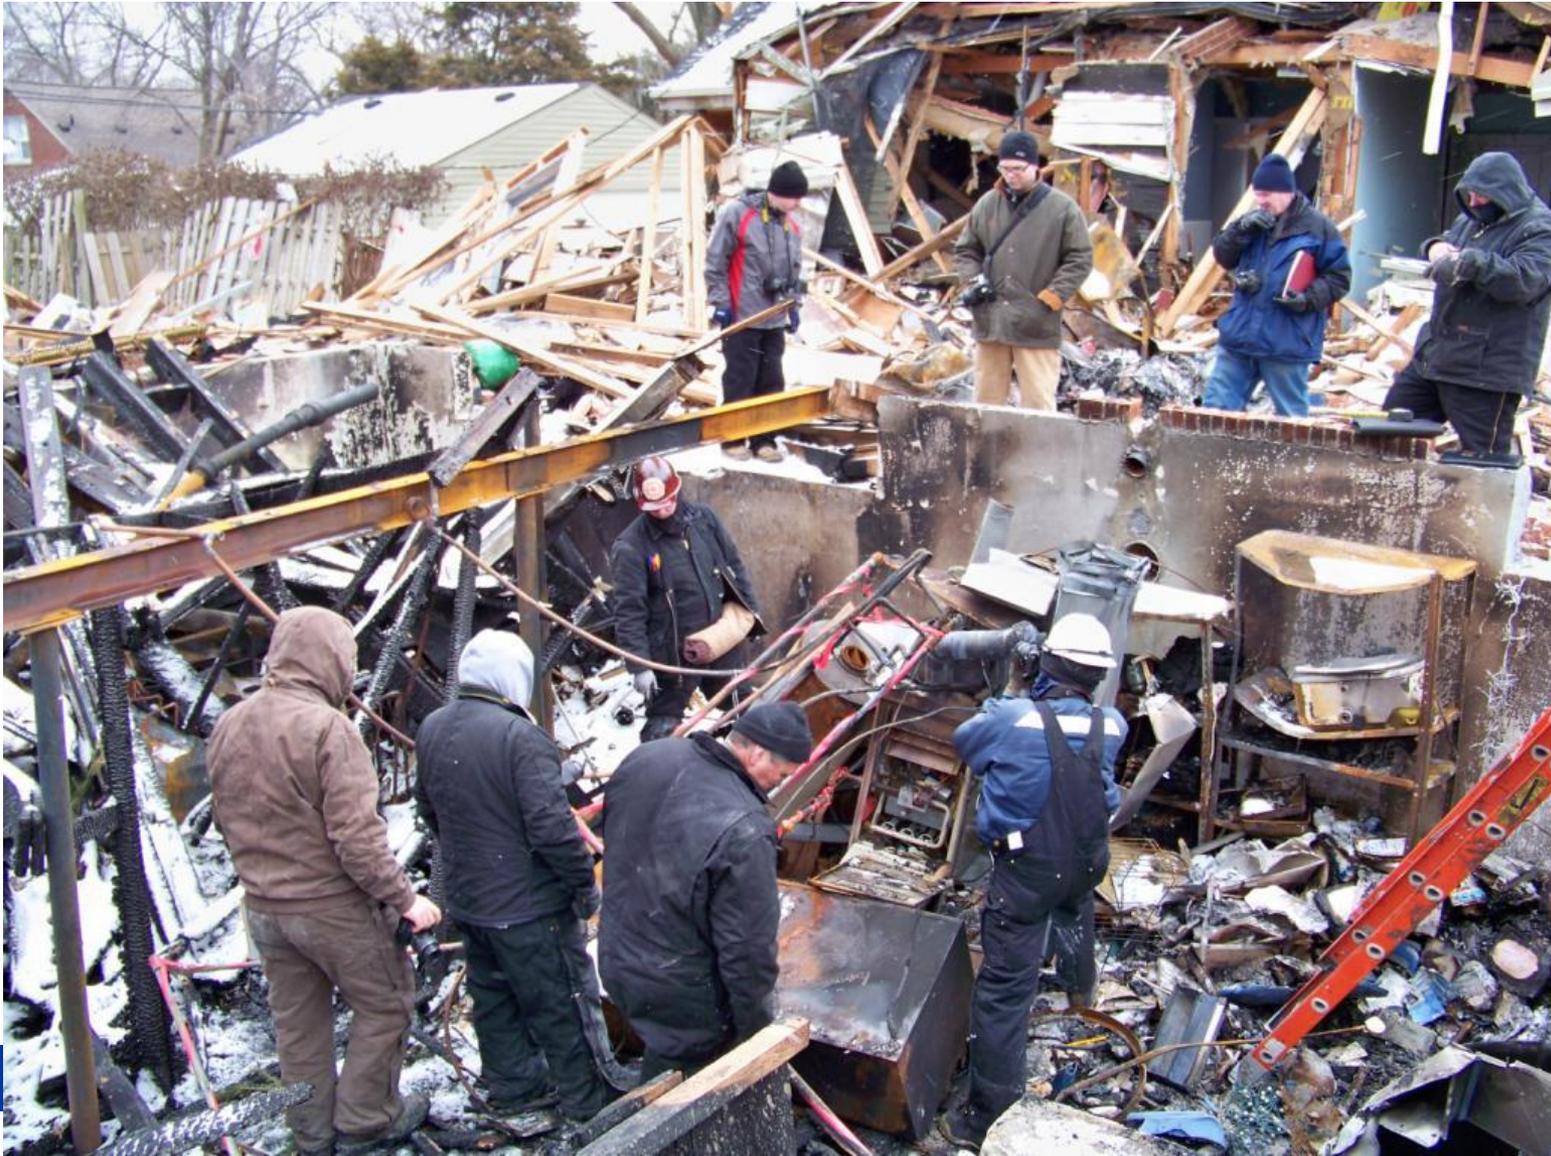
Royal Oaks, MI – Feb 27, 2013

One death -- Two or three homes destroyed, many others damaged.
Gas company crews installing new main hits gas service.

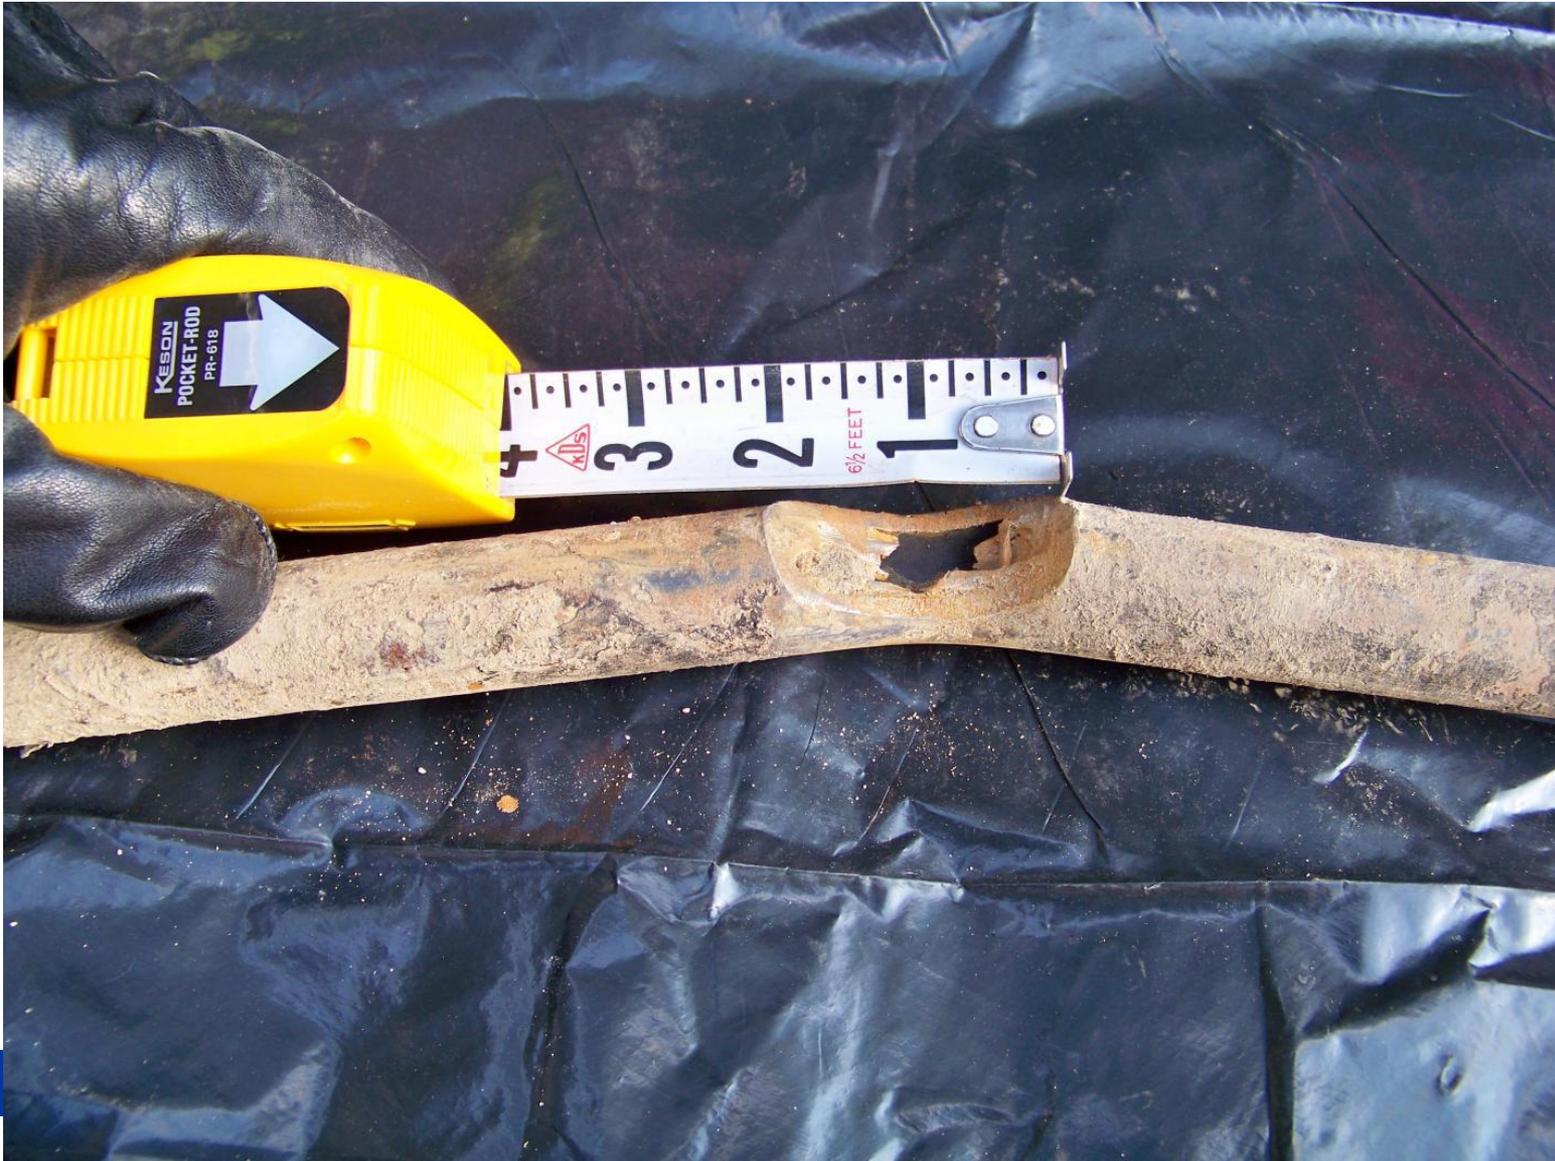
Royal Oaks, MI – Feb 27, 2013

Utility crew came within an inch of puncturing the line in front of Laura Kelley's house a few doors down. She was home with her two children at the time.

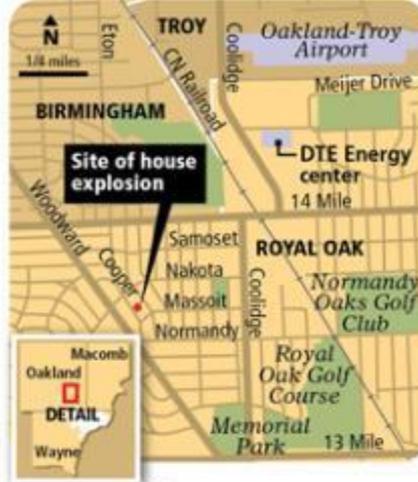
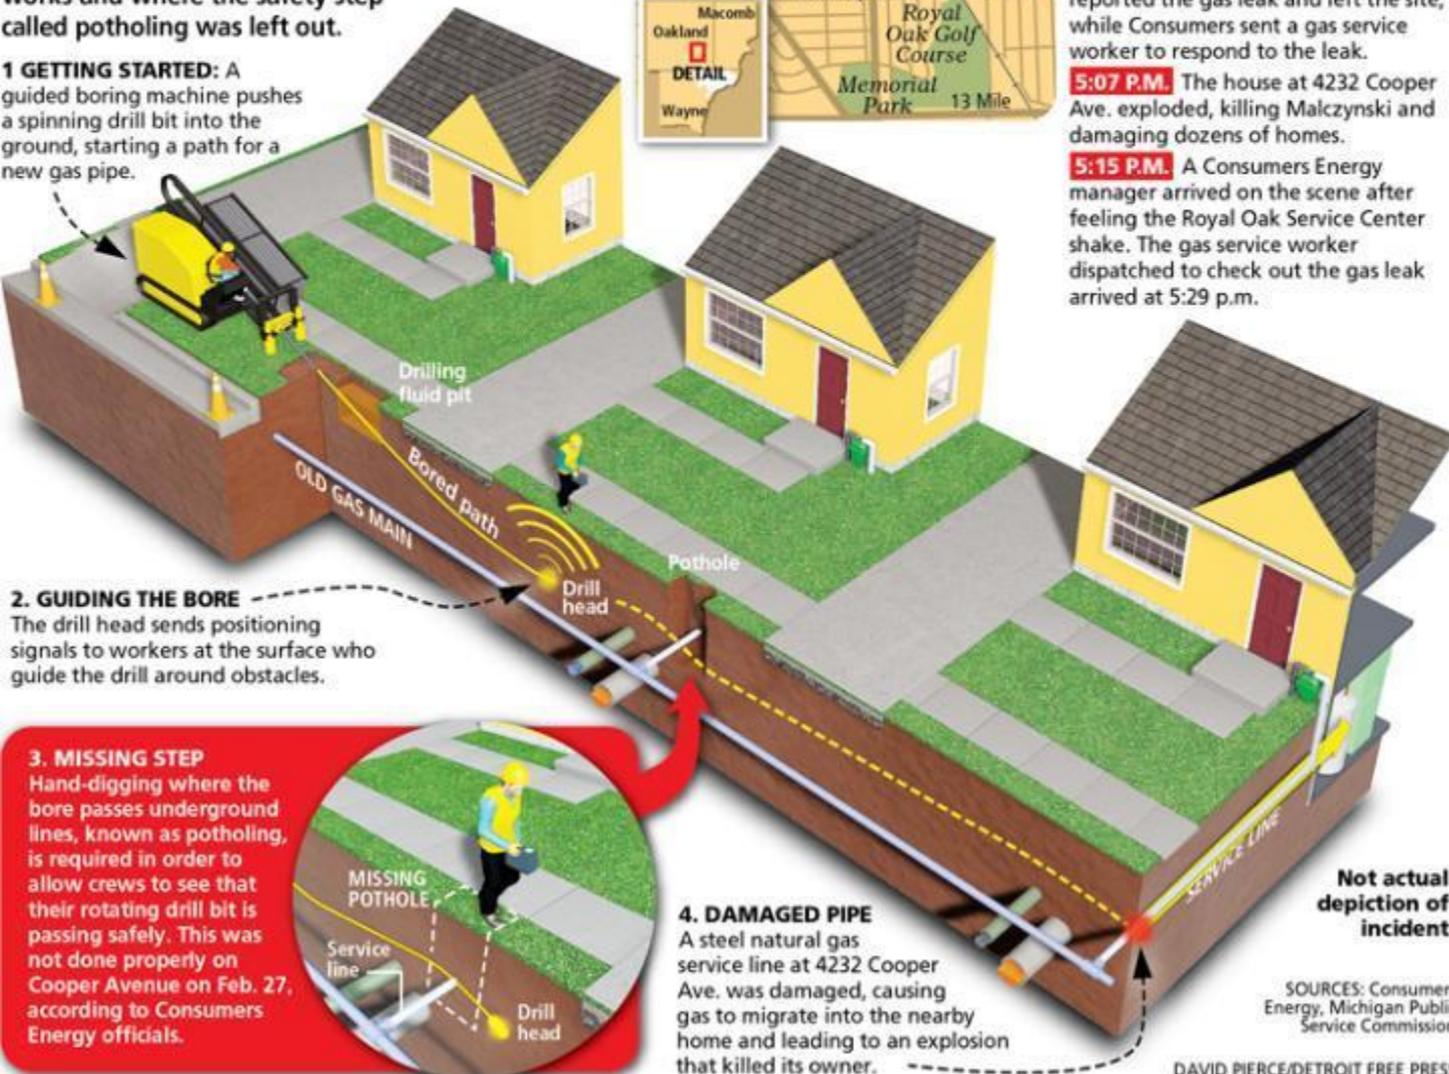
FATAL ERROR

Consumers Energy crews working to replace a natural gas main in Royal Oak on Feb. 27 failed to follow state and federal gas safety regulations and expose the areas where their horizontal drilling passed existing underground service lines.

3. MISSING STEP
Hand-digging where the bore passes underground lines, known as potholing, is required in order to allow crews to see that their rotating drill bit is passing safely. This was not done properly on Cooper Avenue on Feb. 27, according to Consumers Energy officials.

4. DAMAGED PIPE
A steel natural gas service line at 4232 Cooper Ave. was damaged, causing gas to migrate into the nearby home and leading to an explosion that killed its owner.

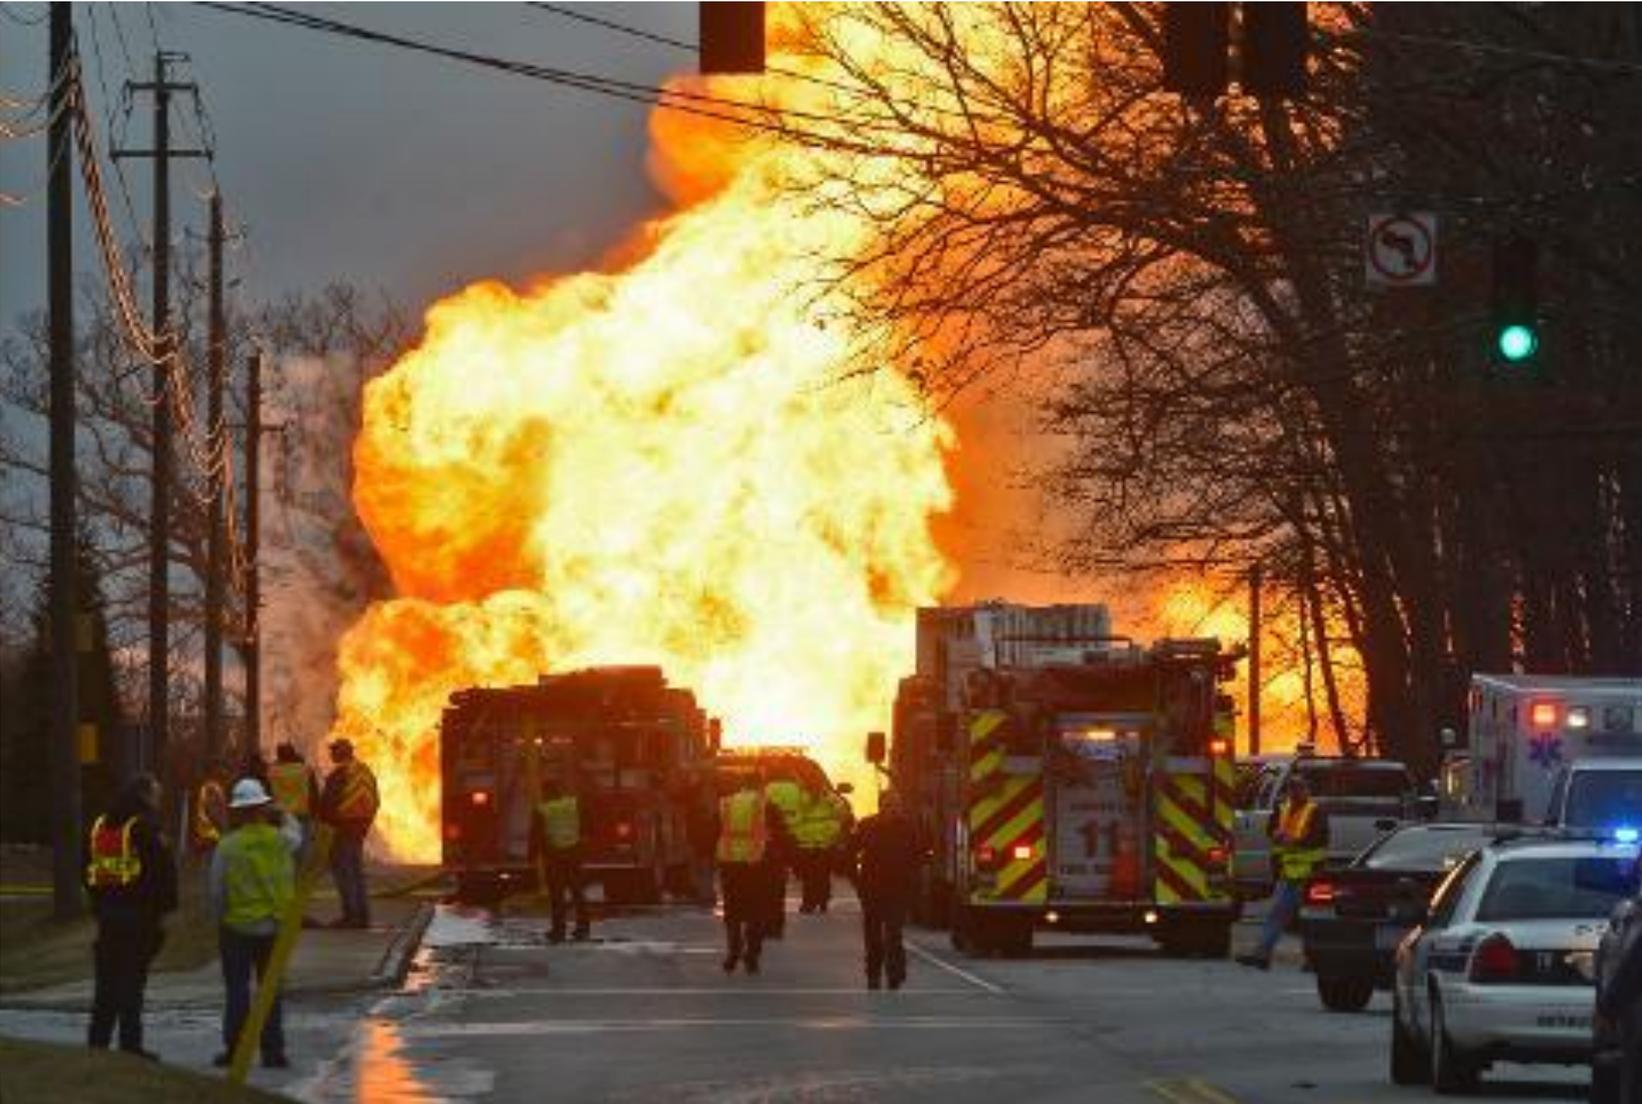
Ashville, NC – Jan. 2014

12” - High Pressure Transmission Line ruptures sending flames hundreds of feet into the air – boring machine damaged the line in 2003.

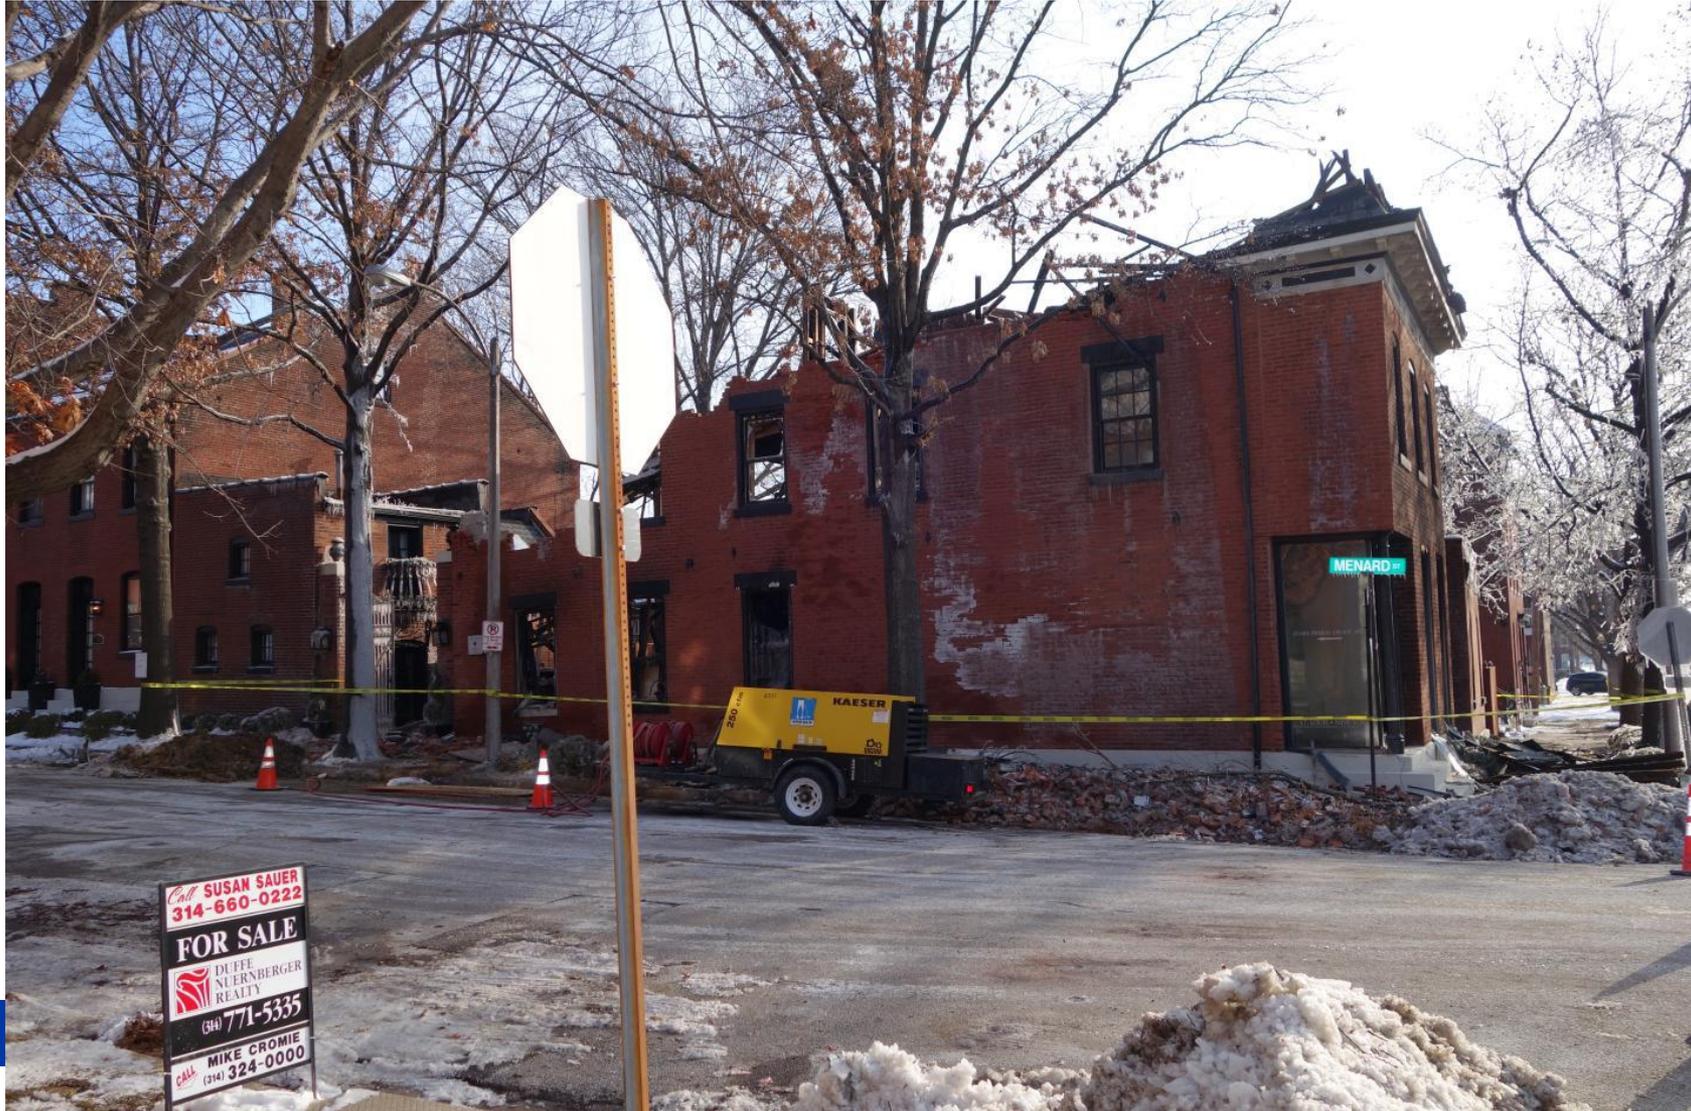
St Louis, MO – Feb. 2014

14 people evacuated less than 1 min prior to explosion - Building destroyed
Contractor installing telecom, crossed a gas service, snow covered locates

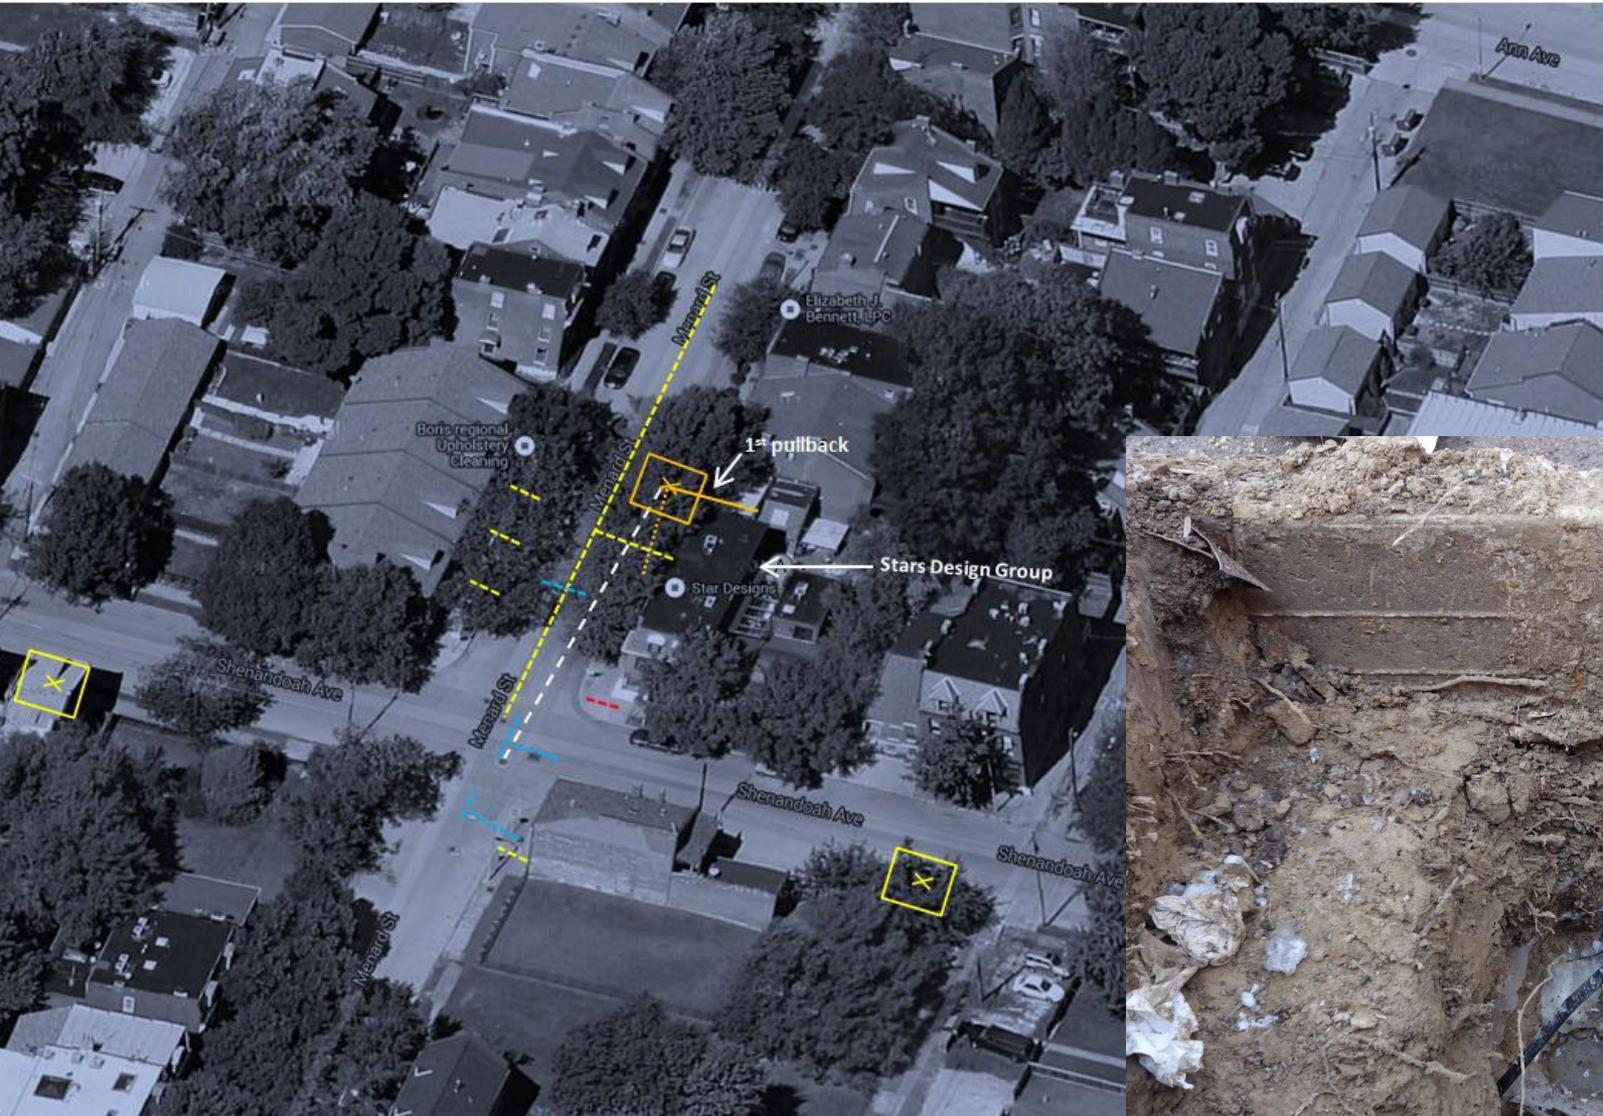
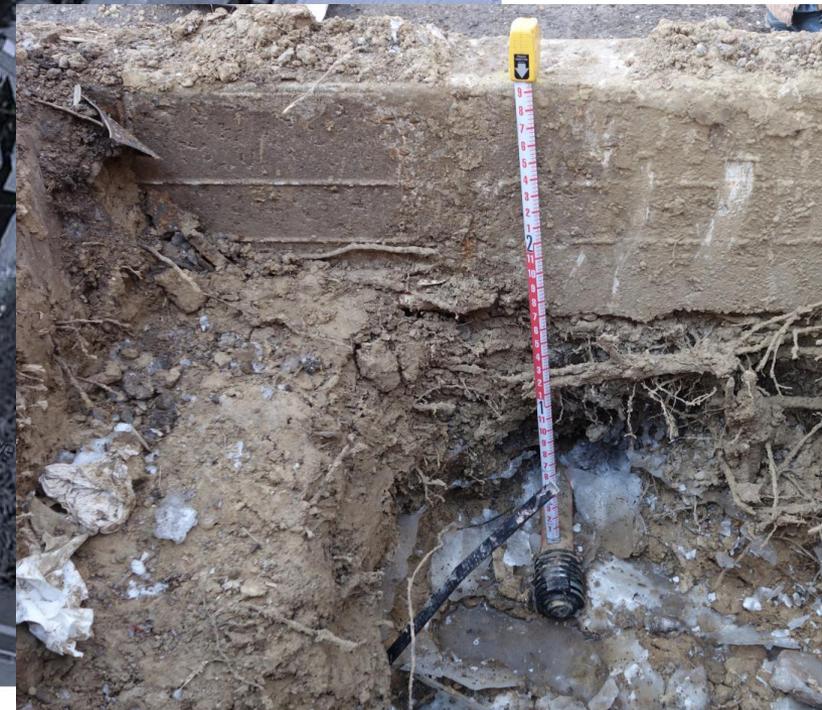
St Louis, MO – Feb. 2014

14 people evacuated less than 1 min prior to explosion - Building destroyed
Contractor installing telecom, crossed a gas service, snow covered locates

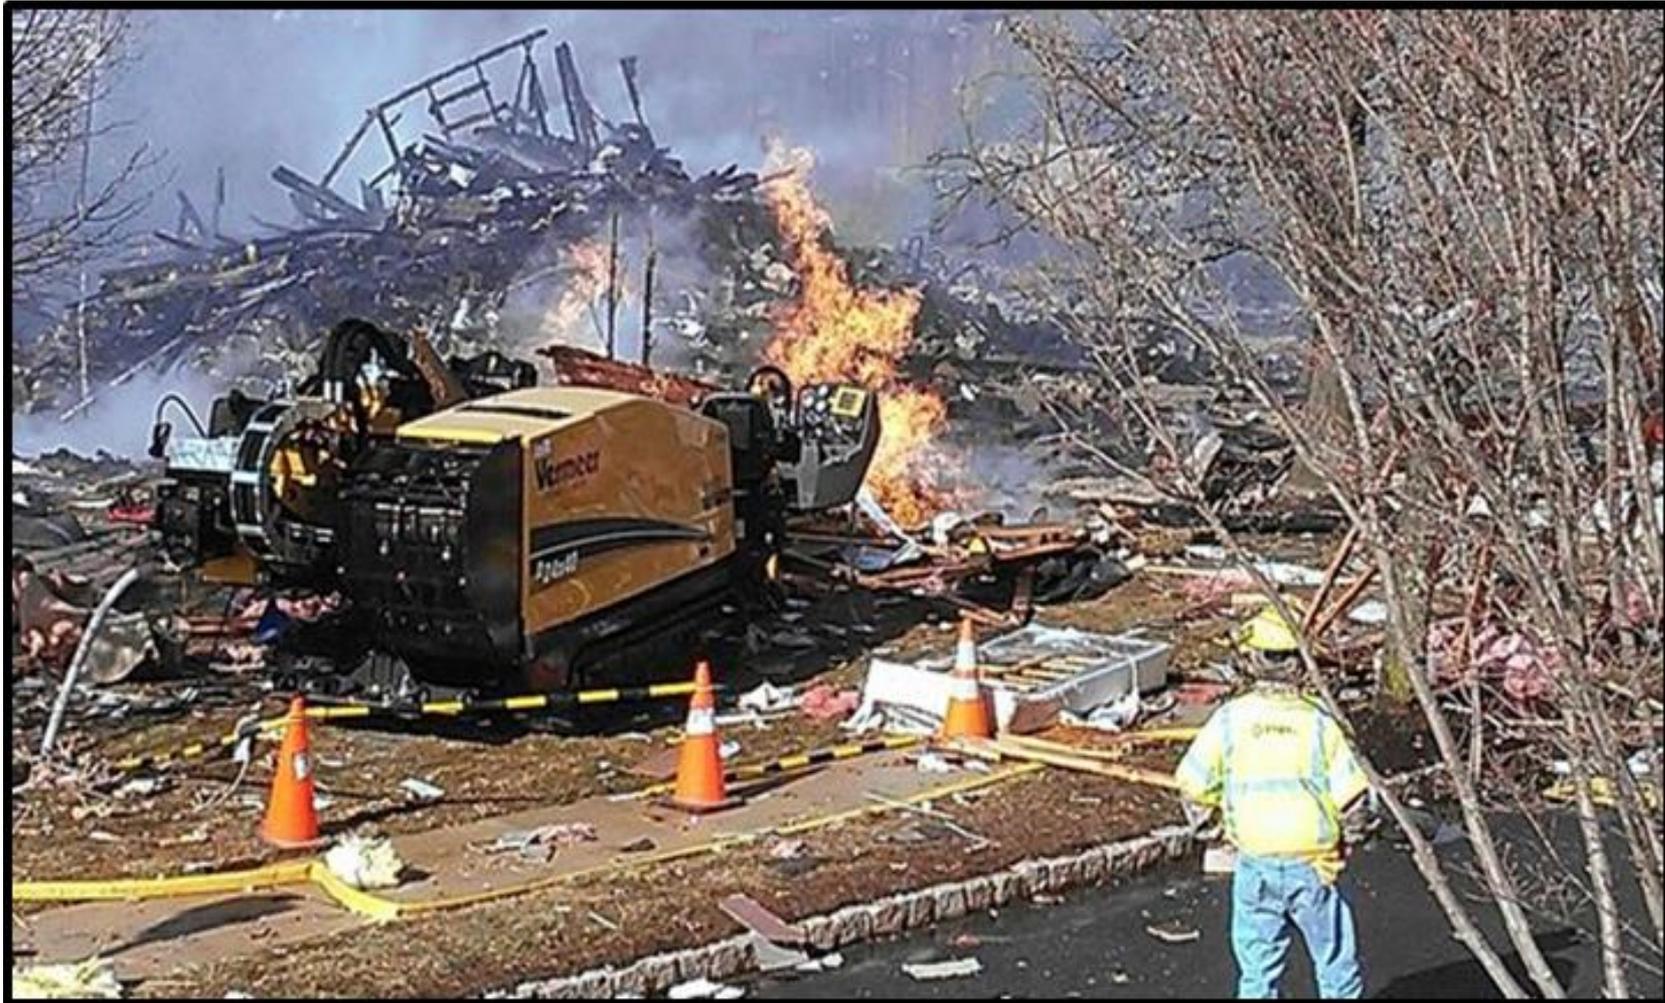
Ewing, New Jersey – March, 2014

1 death, multiple injuries -- A total of 55 homes were damaged or destroyed.

PSE&G Contractor installing electrical conduit via HDD – Details unknown

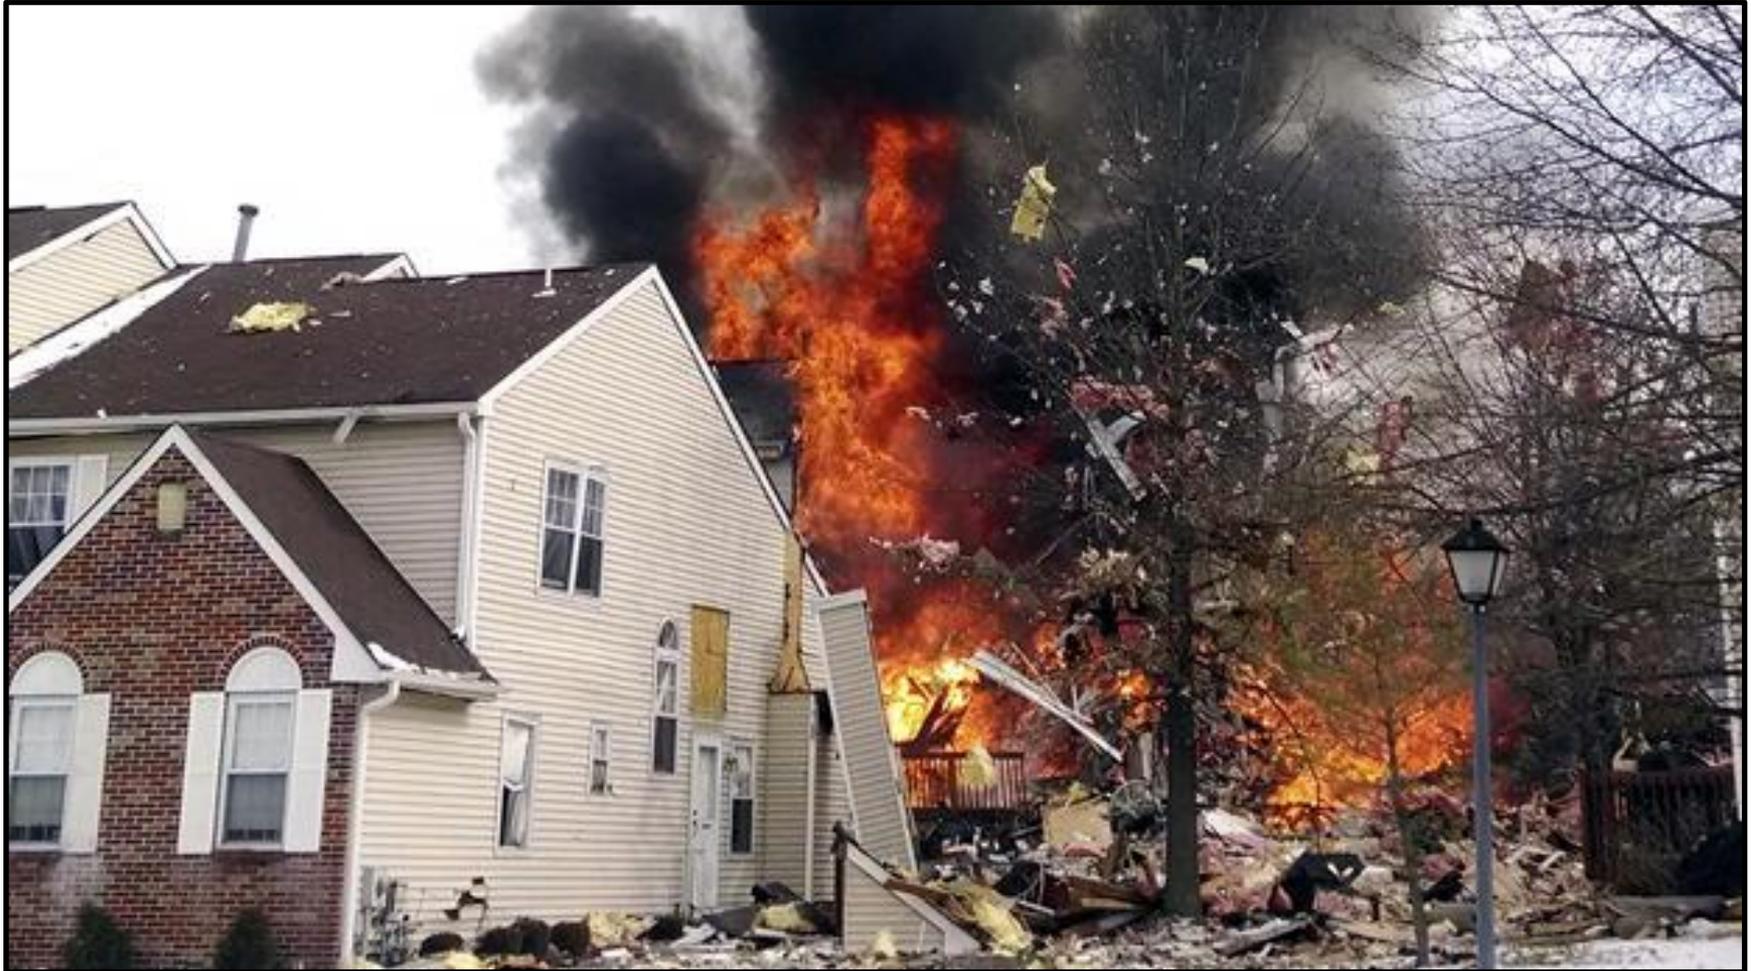
Ewing, New Jersey – March, 2014

The events leading to the explosion began when a contractor working to replace the electric service to the house hit a gas line.
