Utilibond Service Bulletin Surface Cracks

Surface Cracks

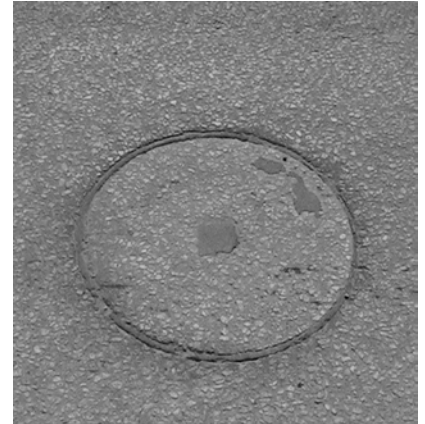
Surface cracks in reinstated roadway.

When a cored hole is reinstated with Utilibond, fine surface cracking may sometimes appear as the Utilibond at the surface dries and hydrates more rapidly than the Utilibond deeper in the kerf. These surface cracks are caused by the tensile stresses that build on the surface of the bond as the Utilibond gives up moisture.

Environmental conditions conducive to high temperature evaporation rates, such as low humidity, extremes in ambient temperature, direct sunlight, and drying winds when the concrete is just beginning to gain strength, causes rapid surface drying and can contribute to surface cracking.

This is because water from the surface layer of Utilibond evaporates faster than moisture can migrate from the underlying material to replace it. The resulting differences in moisture content produces tensile stresses that are relieved by surface cracking of the Utilibond at the surface.

To prevent surface cracking begin the curing process as soon as possible and keep the surface moist using a dampened white-wash brush to paint the surface of the core continuously for a minimum of 30 minutes at 70°F while the Utilibond cures. An alternative would be to spray the surface with a liquid-membrane curing compound such as Utilicure.

To avoid these cosmetic surface blemishes it is important to keep the surface of the core wet until the Utilibond has set for 30 minutes, at 70°F. Failing to keep the surface wet may result in premature hydration of the surface Utilibond, resulting in surface cracks. Opening the road to traffic prematurely can result in erosion of the surface of Utilibond.

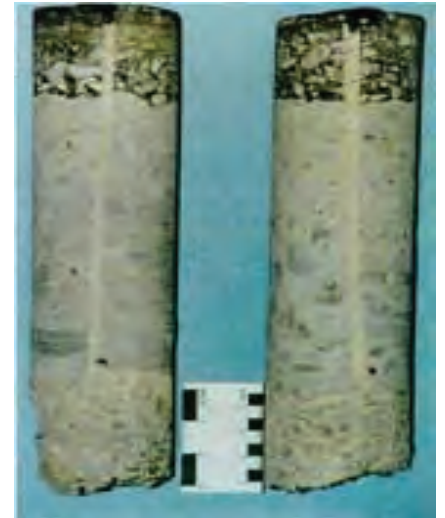
Satellite core samples taken through bonded area of reinstated core. The light gray line is Utilibond showing excellent bonding of asphalt-concrete core (central area) and undisturbed pavement (outer layer).

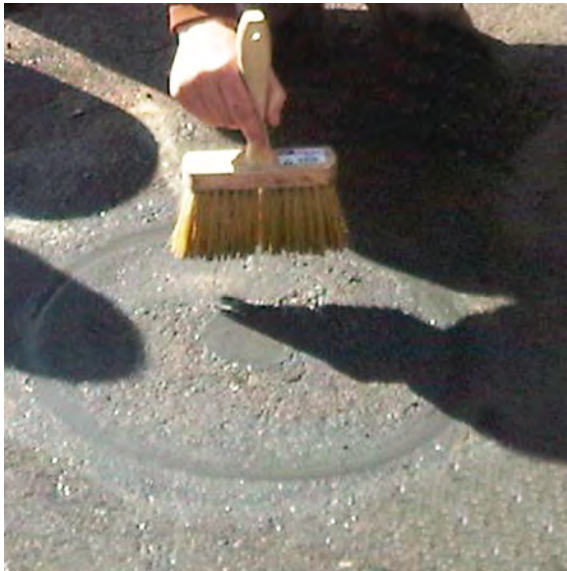
Keep surface wet to prevent premature hydration.

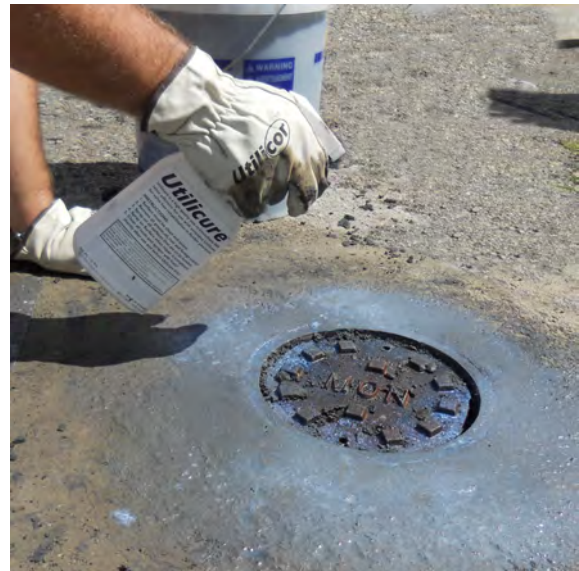
Utilicure being applied to reinstated valve box.
