# Energy Savings From System Efficiency Improvements in Iowa's HVAC SAVE Program

S. Yee, J. Baker, L. Brand, and J. Wells  
*Partnership for Advanced Residential Retrofit*

August 2013

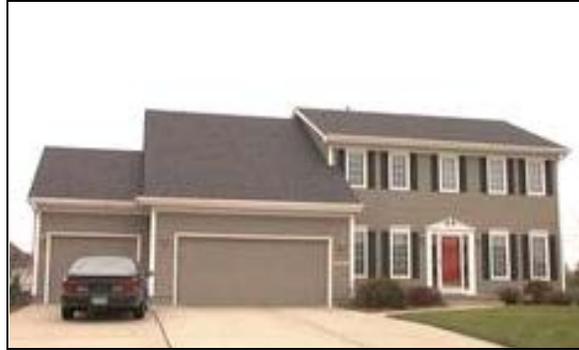
**Figure 9. Test home #1**

Test home #1, shown in Figure 9, is located in Johnston, Iowa. Built in 1993 it has 2,414 ft<sup>2</sup> of conditioned floor space and 100% of the supply and return ducts are in conditioned space. This home contained a 100,000 Btu induced draft furnace rated at 80% AFUE. At test-in the recorded airflow was 1,016 CFM versus the recommended level of 1,300 CFM. Measured ESP was 0.88 i.w.c with the blower motor having a rating of 0.5 i.w.c. The following repairs or adjustments were made to test home #1:

- Furnace replaced, reducing capacity from 100,000 Btu 80% AFUE to 66,000 Btu 95% AFUE
- Combustion tuning conducted on new furnace once airflow was set correctly
- Ductwork leaks repaired and entire duct system sealed using the Aeroseal process.

These repairs were completed in February 2011 and a test-out of the system was done shortly after completion of the work. The new equipment is a 66,000 Btu 95 AFUE condensing furnace, airflow across the equipment was measured at 1,089 CFM, slightly above the recommended level of 990 CFM. After the ducts were repaired and sealed, the new furnace had an ESP of 0.4 i.w.c., well below its rated 0.8 i.w.c. Figure 10 below shows the natural gas consumption of the home pre- and post-retrofit. While the most recent winter was warmer than the previous two, based on heating degree days (HDDs), the natural gas consumption post-retrofit over the four billing periods ending in October, November, December, and January (2011–2012) was 32% less than the same four-month period (2010–2011) when the summer base load is factored out. The HDDs over the same four-month period are 16% fewer post-retrofit than pre-retrofit. When adjusted for HDD differences, the savings was approximately 16%. Data were normalized for weather using ENERGY STAR® Portfolio Manager’s Methodology for Accounting for Weather procedure. Further data collection, especially over a typical winter with temperatures close to design conditions, is required to assess the energy savings from this upgrade.

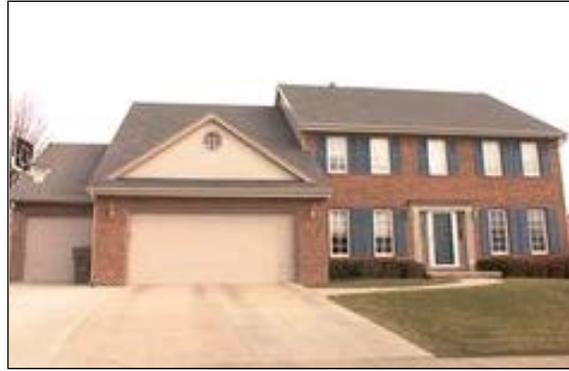
**Figure 12. Test home #2**

Test home #2 is located in West Des Moines, Iowa. It was constructed in 1986 and has 2,698 ft<sup>2</sup> of conditioned space and 100% of the supply and return ducts are in conditioned space. The home contains a 100,000 Btu condensing furnace with airflow at the equipment during initial testing of 988 CFM, below the required 1,500 CFM. The measured ESP was 0.29 i.w.c. versus the blower motor rating of 0.5 i.w.c. Based on the conditions found in the home the following repairs or adjustments were made:

- Ductwork repaired; returns that were found to be communicating with the outdoors sealed
- Additional returns added
- Fan speed increased
- Entire duct system sealed using the Aeroseal process.

The modifications on test home #2 were completed in December 2011. The test-out showed an increased airflow to 1,238 CFM, which raised the ESP to 0.38 i.w.c. The original equipment was not replaced as part of this job.

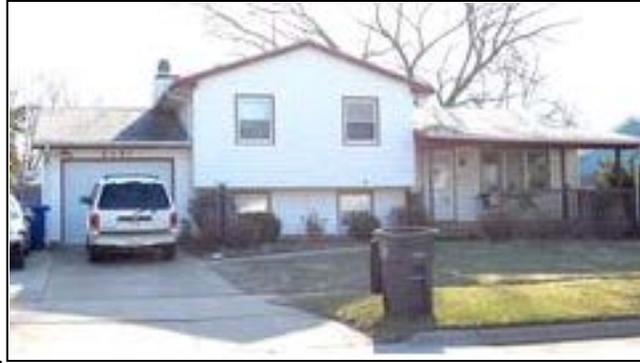
**Figure 15. Test home #3**

Figure 15 shows test home #3, located in Des Moines, Iowa. It was built in 1963 and has 1,520 ft<sup>2</sup> of conditioned floor space. The home contained a 100,000 Btu/h furnace, with a measured airflow at the equipment of 1,425 CFM. The temperature rise across the equipment was 56 °F with an average supply register temperature of 127.9°F. ESP was 0.83 i.w.c., with the blower motor rated at 0.5 i.w.c. The following repairs or adjustments were made to test home #3:

- 100,000 Btu furnace replaced by a 66,000 Btu, 97% AFUE condensing furnace
- Duct system repaired and sealed.

Repairs were completed on test home #3 in December 2011. “Test-out” data on the new condensing furnace showed measured equipment airflow of 875 CFM and an ESP of 0.6 i.w.c. The temperature rise and supply register temperatures were similar to the pre-retrofit conditions.
