# Evaluation of Tellus Underground Technology Corrosion Protection System

November 2012

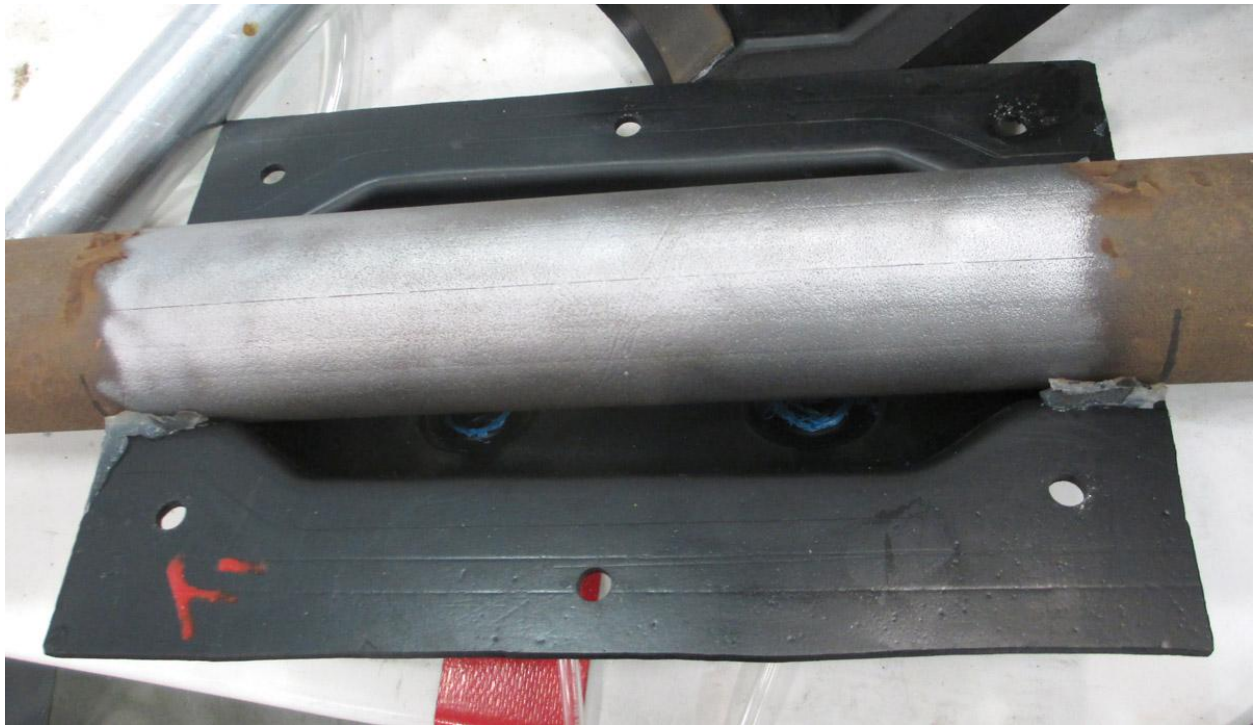
Tellus Underground Technology shipped GTI a 2" pipe with their enclosure unit already attached and sealed to the pipe. In order to establish the baseline condition it was decided to remove the enclosure and grit blast the pipe to a white metal condition.

Figure 1 Surface of 2" pipe after grit blasting

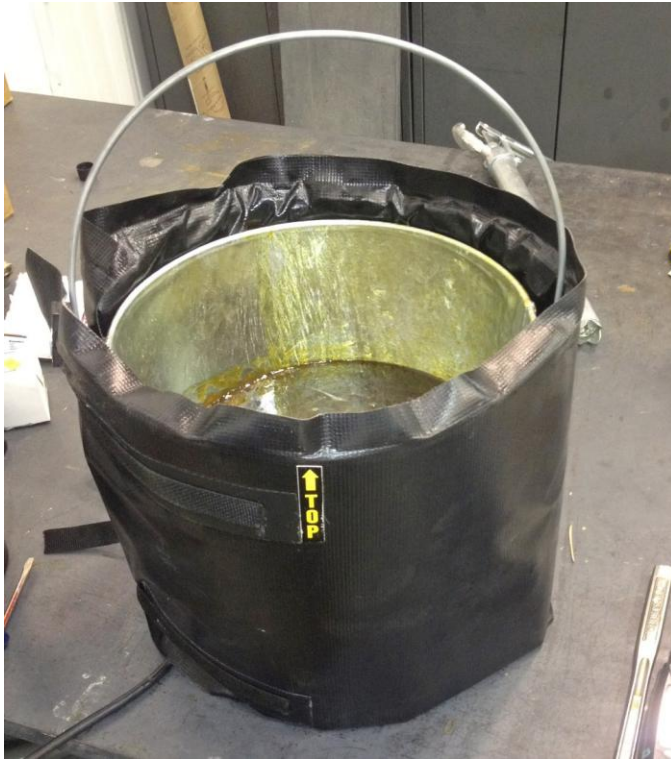
Figure 2 Liquefied Trenton wax-tape primer after heating with bucket warmer

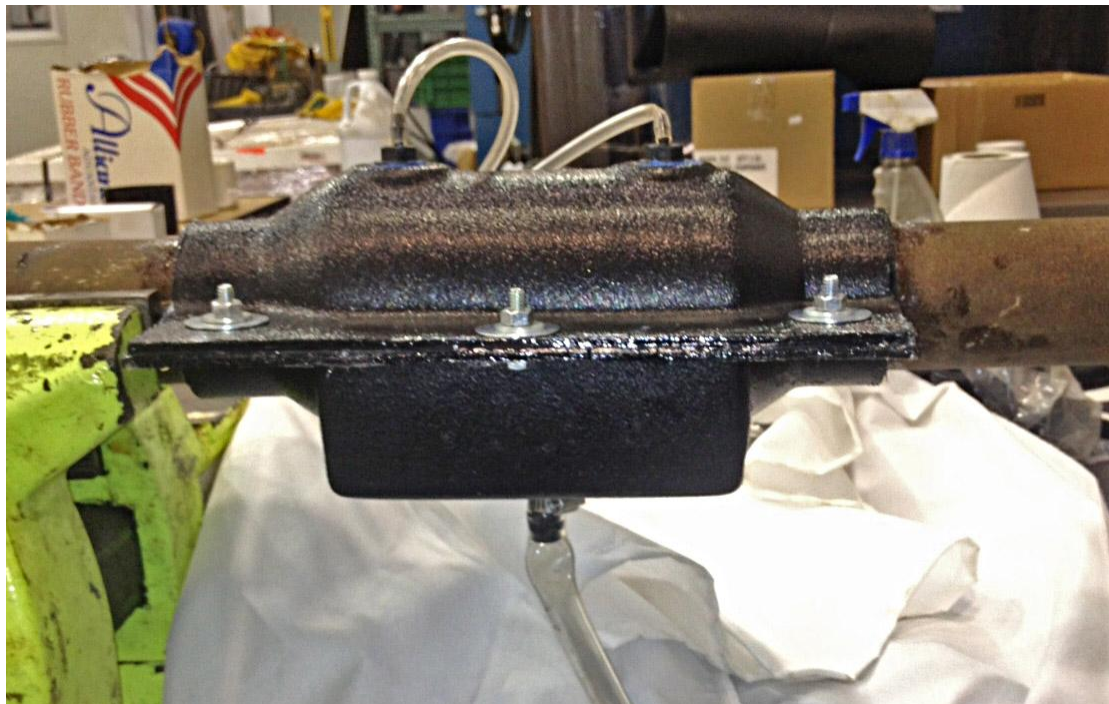
The enclosure provided by Tellus is not intended to be representative of what would be produced for field application. It is intended only as a device for testing the concept of an enclosure filled by hand- pumping in heated wax. For field use a more sophisticated enclosure would have to be designed that could be snapped-on and sealed tight from above in a keyhole. For the purpose of the test of the prototype a layer of silicone sealant was used all around the circumference of the enclosure to prevent leaks of wax. The enclosure was then bolted shut. Three gallons of Trenton Wax Tape Primer (brown) was heated in a steel bucket with a Powerblanket electric bucket heater. Per the recommendation of Tellus the wax was heated to 120F in order to lower its viscosity sufficiently to pump. The hose on the pump came loose and had to be tightened with a hose clamp. After this was accomplished the enclosure was filled with melted wax pumped in from the bottom and it could be seen to be flowing out of the two top bleeder tubes. The heater provided, a Powerblanket BH05PRO 160

Figure 3 Enclosure before filling

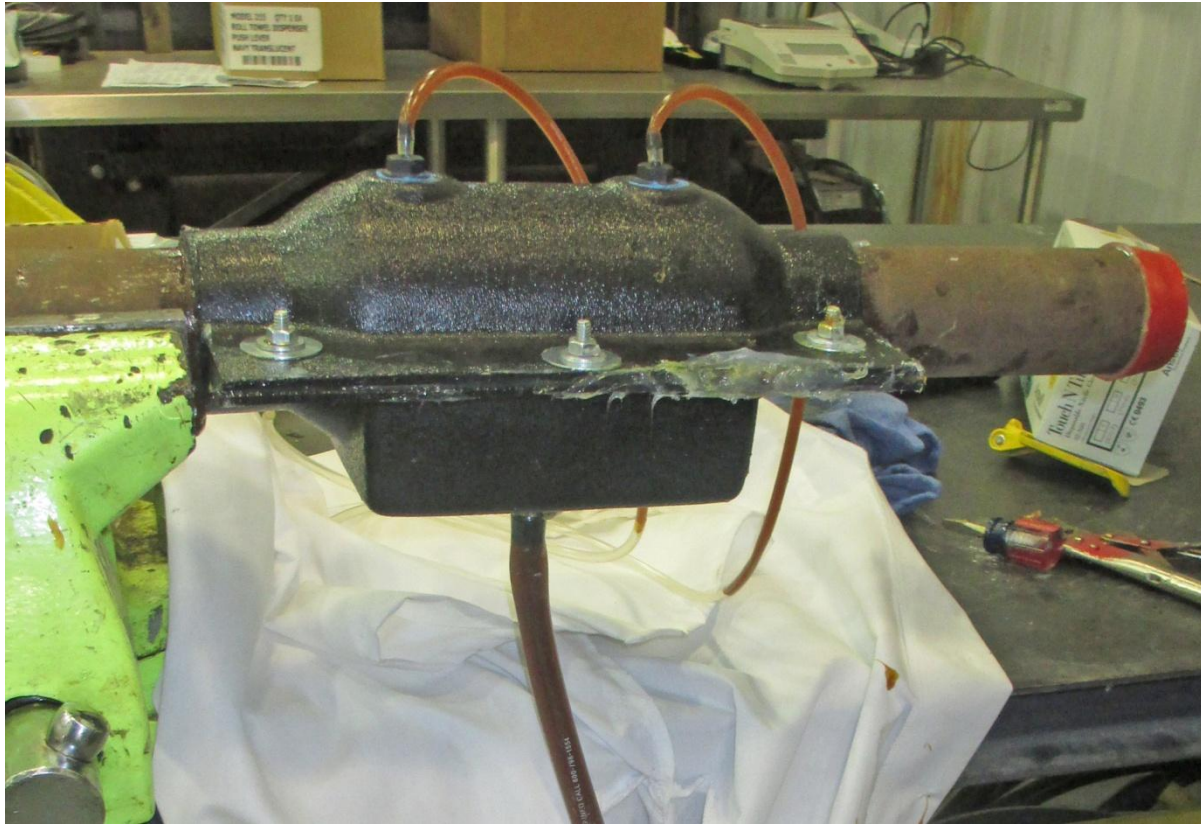
Figure 4 Enclosure after filling with melted wax

After the enclosure was filled with wax, the entire assembly including the hoses was buried in 2.5 cf of sand within a plastic container placed within an environmental chamber. The sand was then brought to 100% saturation with 5% salt solution. The chamber was set to 110°F with continuous air evacuation so that the sand would undergo wet to dry cycling. When the soil saturation dropped below 10% additional water was added to bring the sand back to 100% saturation. This same test has been used before by GTI to test corrosion coatings for underground service.

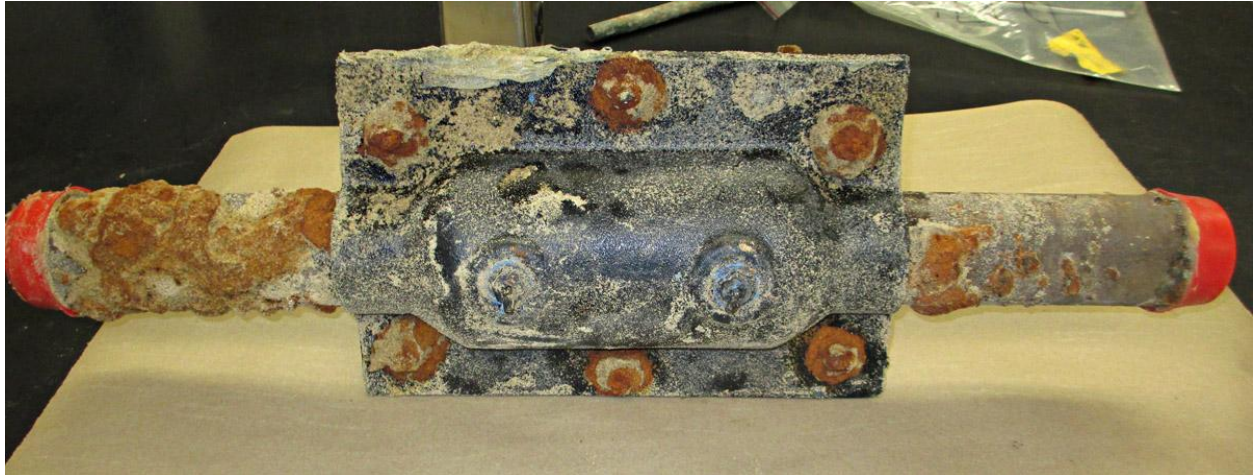
After the completion of 1000 hours of testing, the test specimen was removed from the sand, cleaned, and examined for the corrosion.

Figure 6 Test specimen after removal from corrosion chamber

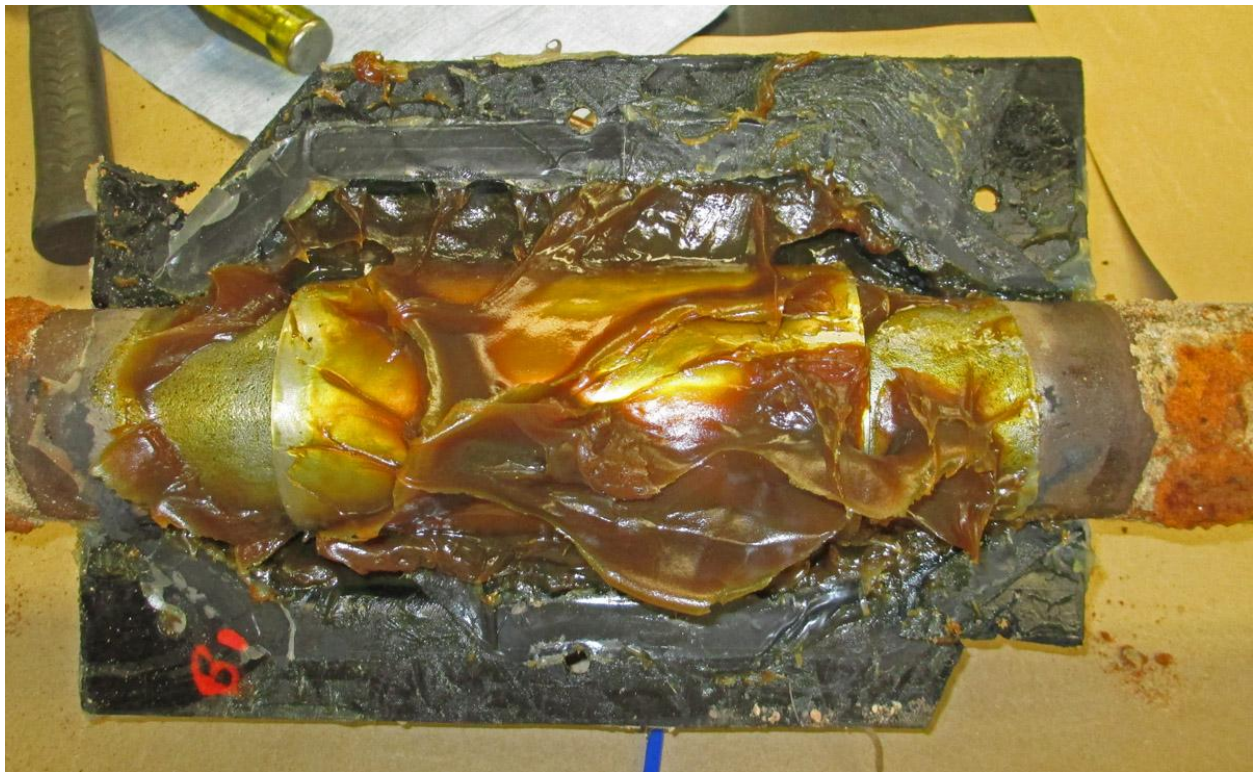
Figure 7 After partial removal of enclosure and wax

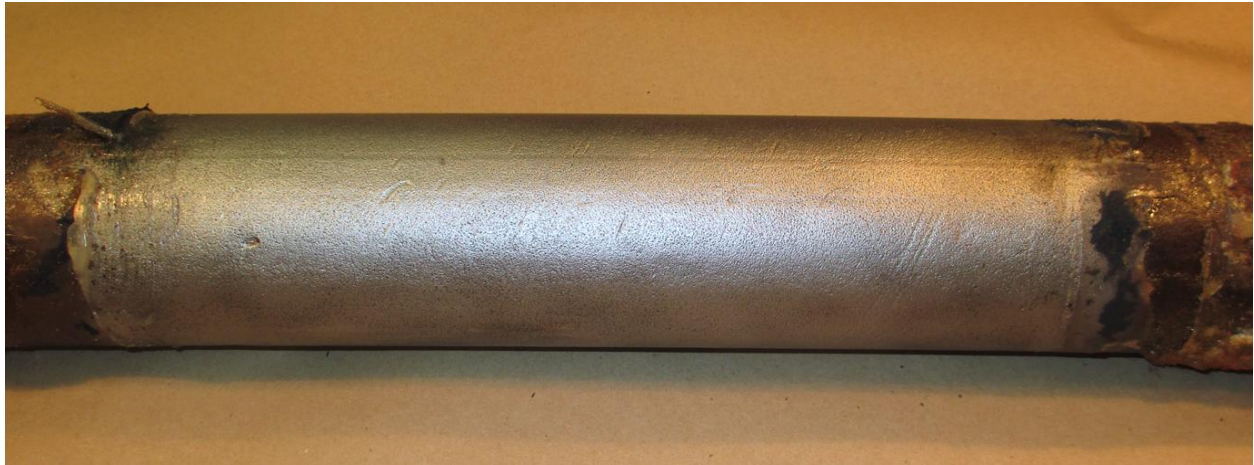
Figure 8 Test specimen after removal of all residual wax

Visual examination of the pipe revealed no rust spots within the wax-filled portion of the enclosure. There were a few lt rust spots at the extreme ends ( collar) of the enclosure probably where wax was unable to flow in.
