The North American Society (NASTT) and the
International Society for Trenchless Technology (ISTT)
International No-Dig Show 2009

Paper A-4-05

POTHOLING WITHOUT POTHOLES: A CORE STRATEGY FOR UTILITY CUT REPAIRS

E. Marshall Pollock, Q.C.

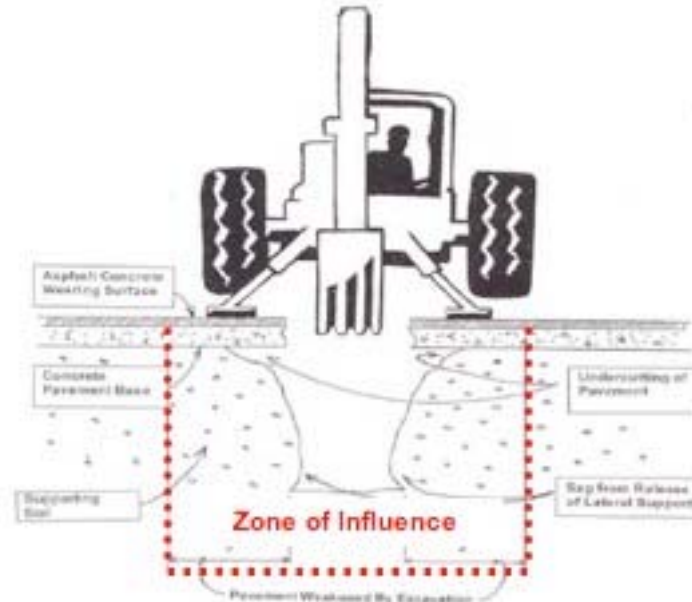
Figure 1: Zone of influence is the area around the excavation that is susceptible to slippage or collapse resulting from external surface load, from vehicles, plant, or excavated material at or near the excavation. [Original illustration © University of Iowa ¹]

How you make the pavement cut is also important. Jackhammers and backhoes not only disturb the original pavement, but the base course and subgrade soils around and below the cut to a distance of 2 to 3-feet beyond the limits of the actual trench. This additional area is termed the “zone of influence”.

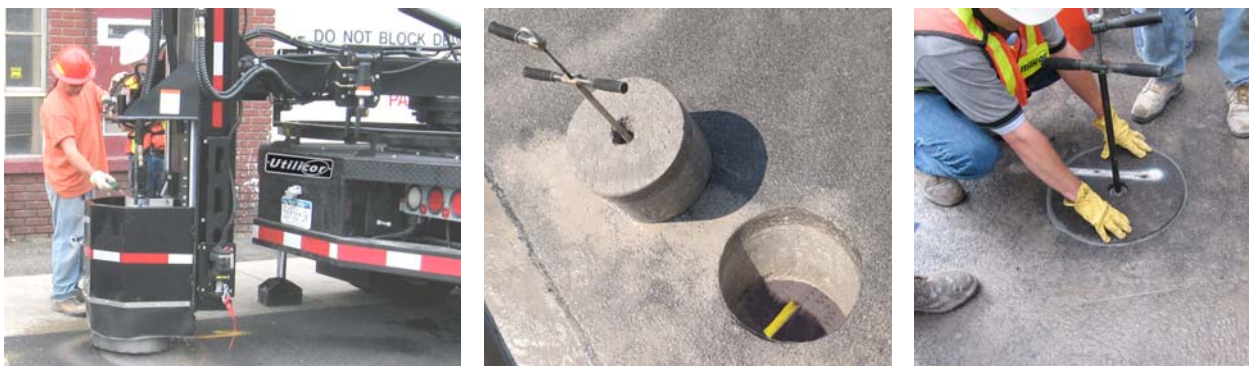
Figure 2: (Left) Rotary coring unit cores 18-inch diameter core; (Center) Core is removed and set aside. Vacuum excavation (not shown) is used to expose the infrastructure; (Right) After the work has been completed, the core is replaced and bonded back into the pavement as a permanent repair.

More recently, as shown in Figure 2, to facilitate vacuum excavation and location of infrastructure that is buried under paved surfaces, a rotary coring device has been adapted to core a small, up to 18-inch diameter, hole through the pavement. The core or coupon of pavement is extracted and set aside to allow vacuum excavation to expose the underground plant. After the underground work has been completed

and the hole backfilled to the base of the pavement, the same core of pavement that was removed earlier can now be bonded back into the roadway with a special bonding agent as a permanent repair. No pavement spoil is created, no new paving materials are required to repair the road surface, and the road can be safely reopened to traffic again within 30 minutes of the repair, thus reducing traffic congestion and public inconvenience.

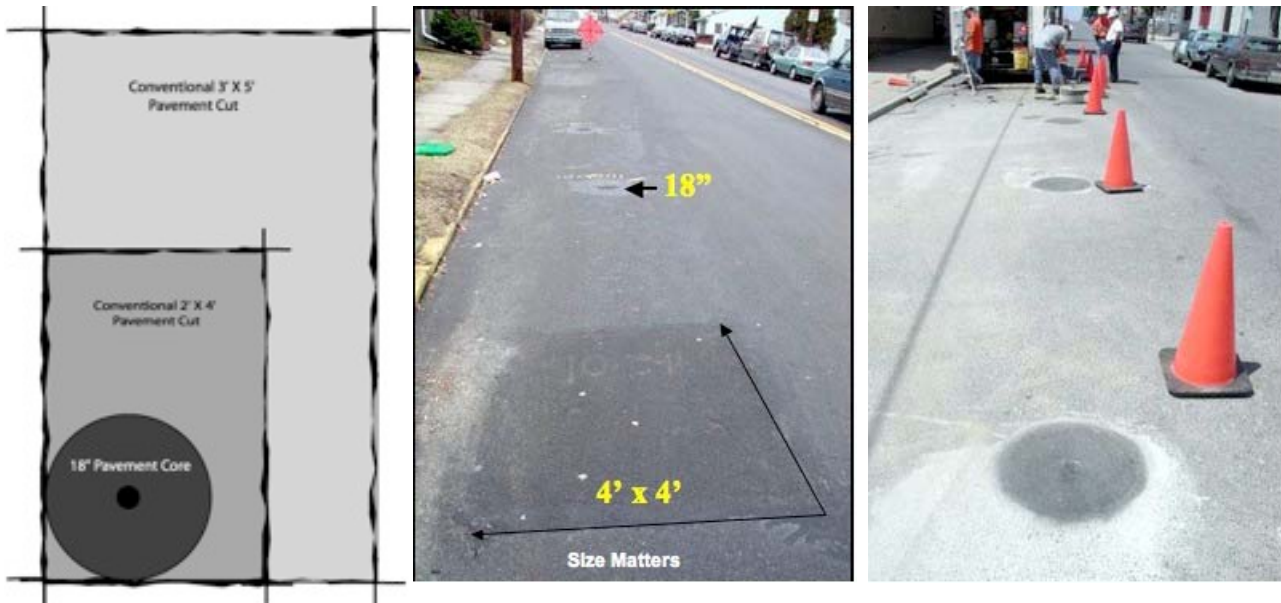
Figure 3: Size matters. (Left) An 18" diameter circular keyhole is less than half the size of a standard 2-foot x 4-foot cut and, because it is circular, has no corners in which to develop pressure cracks. (Center and Right) The large conventional repair of a 2-foot x 2-foot utility cut with a 1-foot cut back all around (making the area to be repaired 4-feet x 4-feet), is much more intrusive than the 18-inch keyhole behind or the series of keyholes on the right.

As can be seen in Figure 3, size also matters. The smaller and more precise excavation and permanent repair of a keyhole core requires no subsequent paving or milling and overlay, performs better and is much more aesthetically pleasing than the larger rectangular road cuts

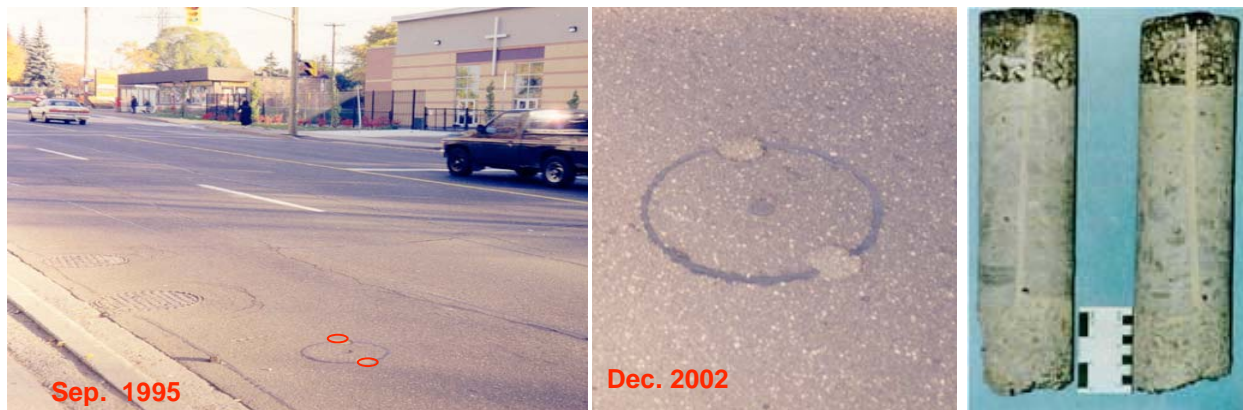
Figure 4: To test the effectiveness of the bond, Golder cut satellite core samples through the kerf of previously reinstated cores. These samples (right) showed perfect and complete bonding or adhesion of the *Utilibond* to both the surface of the core or coupon and the surface of the remaining pavement, as well as excellent “cohesion” through the joint itself. The light gray line, in the photograph, is *Utilibond* showing excellent bonding of the asphalt-concrete core (central area) to the undisturbed pavement (outer layer) with complete infilling of voids in pea gravel (bottom). The core which is directly in the wheel path of a transit lane of this arterial road showed no deflection from the time it was first reinstated in September 1995 (left) to December 2002 (center) notwithstanding the fact that during the seven year interval more than 145,000 transit buses and 13 million commercial and other vehicles have passed directly over the keyhole with no apparent weakening or other degradation of the reinstated core or the adjacent road system or paved surface.

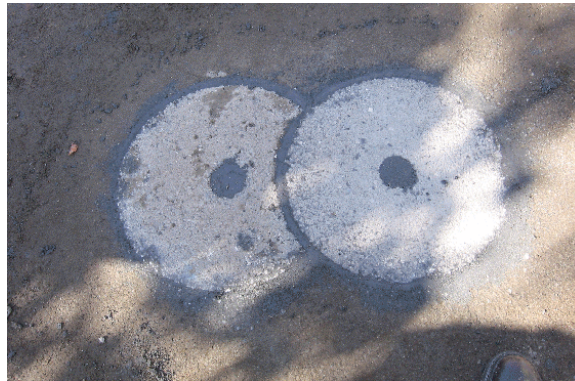
Figure 5: Sometimes two cores may be better than one. For example, a locate may be slightly off or a larger opening may be required to make the repair or properly locate and identify the infrastructure. In that case, a second or overlapping core may be cut to expose the infrastructure. When the work has been completed and the excavation backfilled, the two cores can be reinstated as a permanent repair using the same technique as for a single core.

The Standard is far-reaching and comprehensive. The maximum diameter of the core is specified to be 460 mm or 18-inches, but, with prior approval of the city, larger cores up to 610 mm or 24-inches in diameter, or overlapping cores, may also be cut. This is important because some locates may be a little off or a larger opening required to actually perform the repair work.

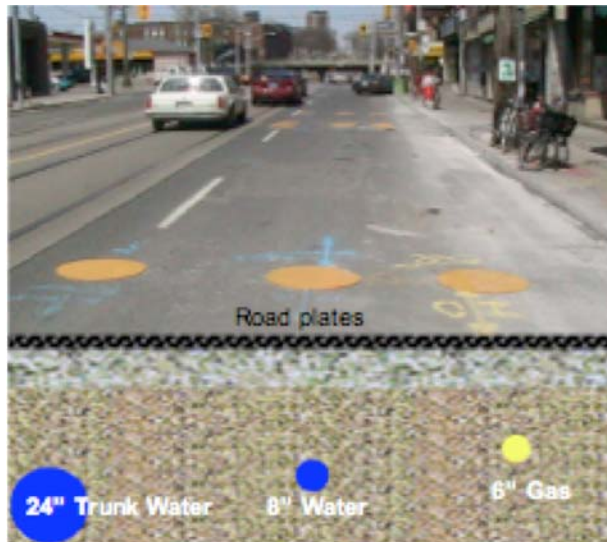
Figure 6: (View: Bathurst Street in Toronto looking north.) Pothole cores are cut to identify potential conflicts during HDD and temporarily capped with a circular road plate that allows traffic to flow uninterrupted on this busy thoroughfare while directional drilling takes place.

For example, as shown in Figure 6, in the City of Toronto, Enbridge Gas Distribution needed to tie in a new 4-inch gas main laid down the west side of a busy arterial street, to services in residences and businesses on the east side, using directional drilling. Before the drill pits were dug through the sidewalk on the west side, a series of five cores were cut in the roadway along the intended drill paths to “pothole” and identify the exact location of potential north-south conflicts that included a 24-inch water main, an 8-inch water main, a 6-inch gas line and two electrical and telephone lines running under the sidewalk on the east side of the street.

In order to make the most efficient use of the drilling crews time, the cores were cut and the conflicts exposed by vacuum excavation in advance of the drill shots and road plates inserted to allow the road to be kept open to traffic. When all of the potholes in two or three blocks had been dug, the directional drill

arrived on scene and began its work of safely completing the connection. A core reinstatement crew followed up backfilling and reinstating the cores and the entire project of more than 4.5 miles was completed in this manner. Except for very brief periods of time, at least two lanes of traffic remained open at all times.
