ARUN LNG RECEIVING HUB & REGASIFICATION TERMINAL – THE FIRST CONVERSION OF LNG PLANT BECOME LNG REGASIFICATION TERMINAL

Nuranti, Sr. Engineering I Process Tech. Optimization, PT Pertamina (Persero), Indonesia

I. INTRODUCTION

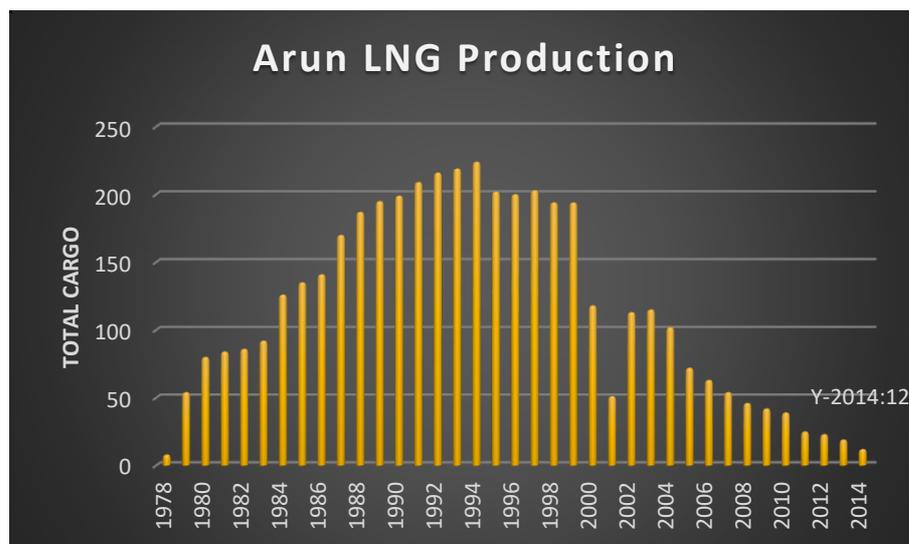
Figure-1 Arun LNG Production

Arun LNG production has been declined since early 1995 along with the declined of gas deliverability of the upstream gas field and there were no new prospected gas reserves. With the waning supply from gas fields, Arun LNG Plant ceased its activity after 37 years of operation. The last LNG cargo was exported on October 15, 2014.

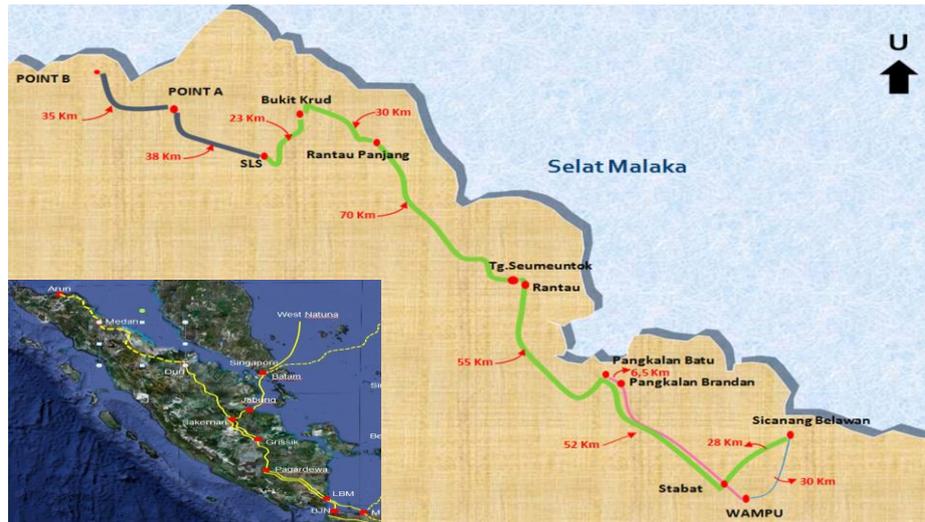
Figure-2 Arun-Belawan Pipelines

Arun's LNG Receiving Hub & Regasification Terminal has now converted its function into regasified LNG facility that operated by PT Perta Arun Gas (subsidiary of Pertamina), and distribute the gas to the Gas Power Plant of PT PLN (Persero) in Belawan through to 350km of Arun-Belawan open access gas pipeline that belongs to PT Pertagas (subsidiary of Pertamina). The regasified gas also send to another Gas Power Plant of PT PLN (Persero) in Lhokseumawe (side by side with Arun location).

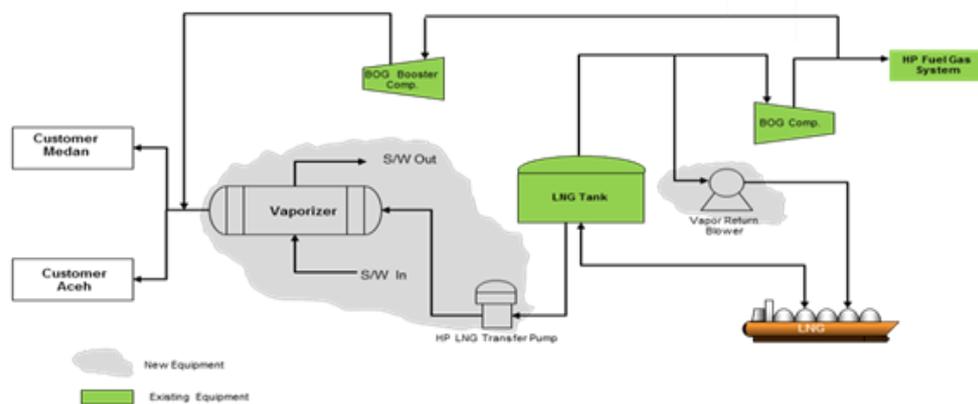
Figure-3 Flow Diagram of Arun LNG Receiving & Regasification Plant

FEED study had performed to study this project. The concept of the conversion project was primarily to utilize the existing LNG storages and loading facilities as receiving and hub terminals and add the new facilities such as LNG regasification and gas delivery to the gas customers. The conversion project also has utilized those parts of the existing facilities to be used in order to optimized and reduced the capital expenditure of the project.

LNG from LNG ship is transferred to LNG Storage Tank by Cargo Pump. LNG from storage tank is pumped by LNG Transfer Pump then sent to regasification process and vaporize by using ORV (Open Rack Vaporizer). This vaporizer is using seawater as heating media to vaporize LNG. Vapor LNG from ORV is sent to customer. During LNG unloading from ship to LNG storage tank, BOG (Boil of Gas) produces significantly. This BOG will be sent and split into two stream, one stream as BOG Return to

ship and another stream sent to BOG Compressor to be used as HP Fuel Gas for Power Generator. While there is excess HP Fuel Gas, it will be recompressed by BOG Booster Compressor, then the discharge will be combined with the outlet LNG Vaporizer and sent to customer.

The existing equipment to be used includes:

Additional Facilities to be installed are includes:

- LNG Transfer Pump (G-2304 A/B/C)
- Primary LNG Transfer Pump (G-2306 A/B)
- LNG Open Rack Vaporizer (E-2302 A/B/C)
- LNG Back-Up Vaporizer (E-2304 A/B)
- LNG Back-Up Pump (G-2305)
- Fuel Gas Electric Heater (E-2303 A/B)
- LNG Vapor Return Blower (K-2302 A/B)
- Piping & control system modification

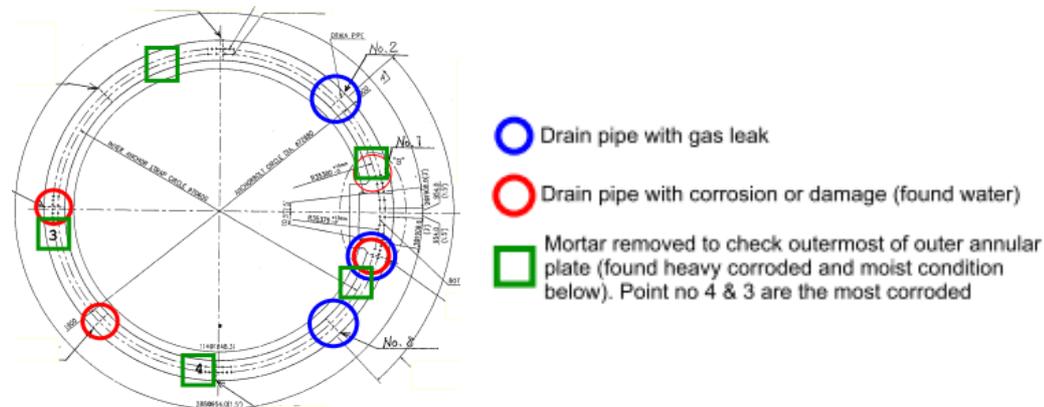
Figure-4 External Inspection Finding

External inspection result is drain pipes in good condition even though some water was observed. There is a gap of 25 to 35 mm between outermost of outer tank annular plate and concrete ring foundation since bituminous sheet were already gone. The plate condition is in heavy corrosion and excessive deterioration.

Based on those inspections, it was decided to have a short-term repair approach as follows; repair sealant, install bituminous sheet and mortar, as well as seal hydrocarbon leak points. Furthermore, corroded parts of outer tank and bottom tank heater were repaired.

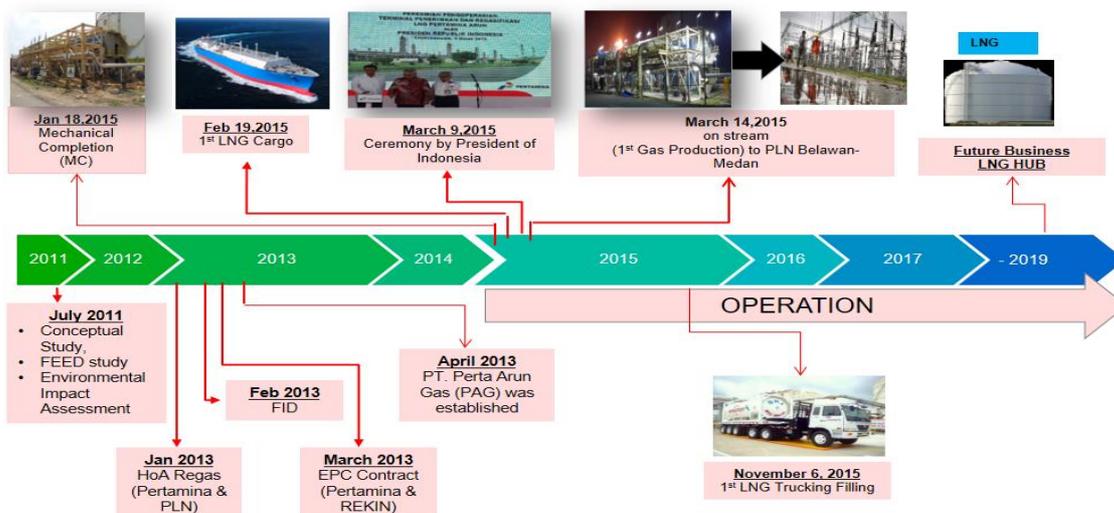
A. Historical timeline

Terminal construction: Construction commenced in March 2013 and was successfully completed in early 2015. The timely construction has displayed Pertamina's excellent progress in meeting its scheduled in line with the termination of Arun LNG Plant operation on End 2014.

Startup and operations: After mechanical, commissioning and start-up the regasification terminal was on stream as of January 2015. Its first LNG cargo was supplied from Tangguh LNG terminal on February 19th, 2014 with a volume of 119,000m³. The upcoming projects are being developed, such as the revitalization LNG Hub of LNG trucking, cooling down, bunkering, and break bulking to the small LNG Carrier
