Keyspan and Con Edison win approval for Keyhole Coring and Reinstatement from New York City DOT.

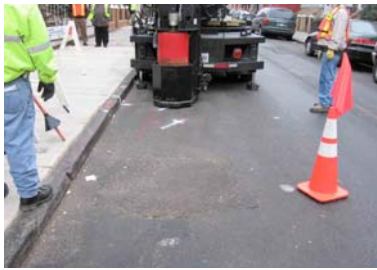
1. Coring unit with conventional repair in foreground

The pictures literally tell the story from a comparison of a conventionally excavated and repaired rectangular utility cut (seen in the foreground of the first picture), to the reinstated core that is almost invisible, at the end.

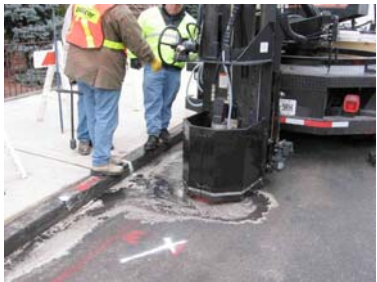
2. Coring begins

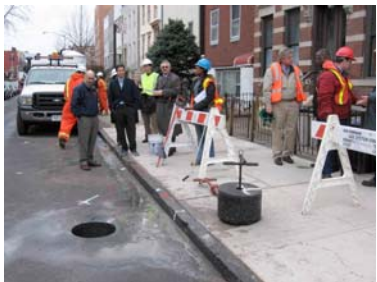
3. 13-inch asphalt core

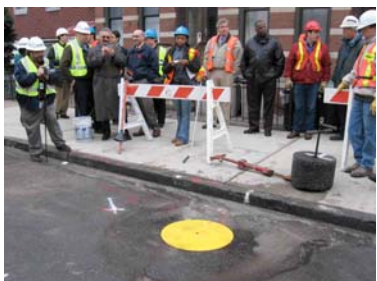
4. Temporary road plate

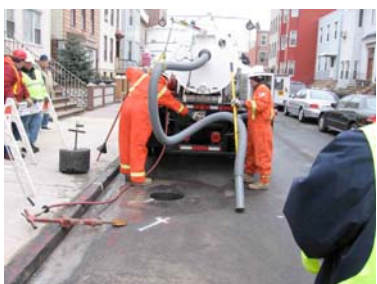
5. Vacuum excavation

In addition to the Utilicor coring equipment and Utilibond, the demonstration included the Excavac vacuum excavation system, service cut-off tools from various manufacturers and the soil compaction supervisor from MBW.

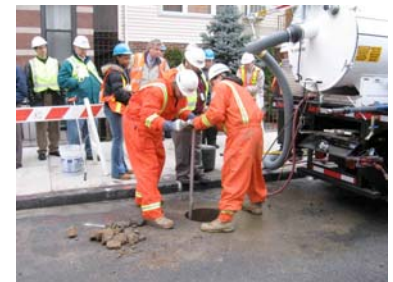
6. Turning off the gas

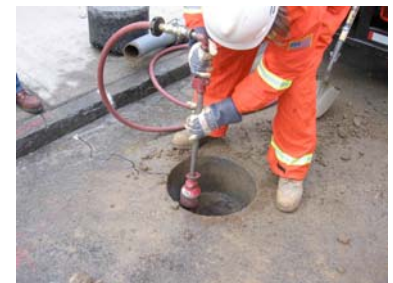
7. Compaction (note wire from soil compaction supervisor)

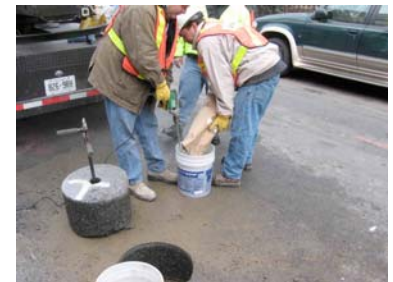
8. Mixing the Utilibond

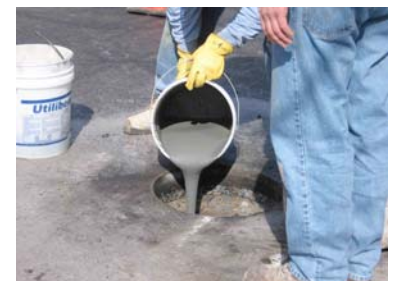
9. Pouring Utilibond in the hole

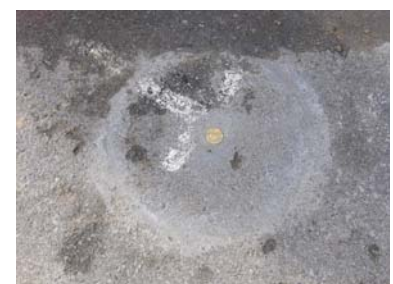
10. Reinstated core – almost invisible
